DEC-12-HVRTP-A-D

**VR14 and VR20
troubleshooting
procedures**

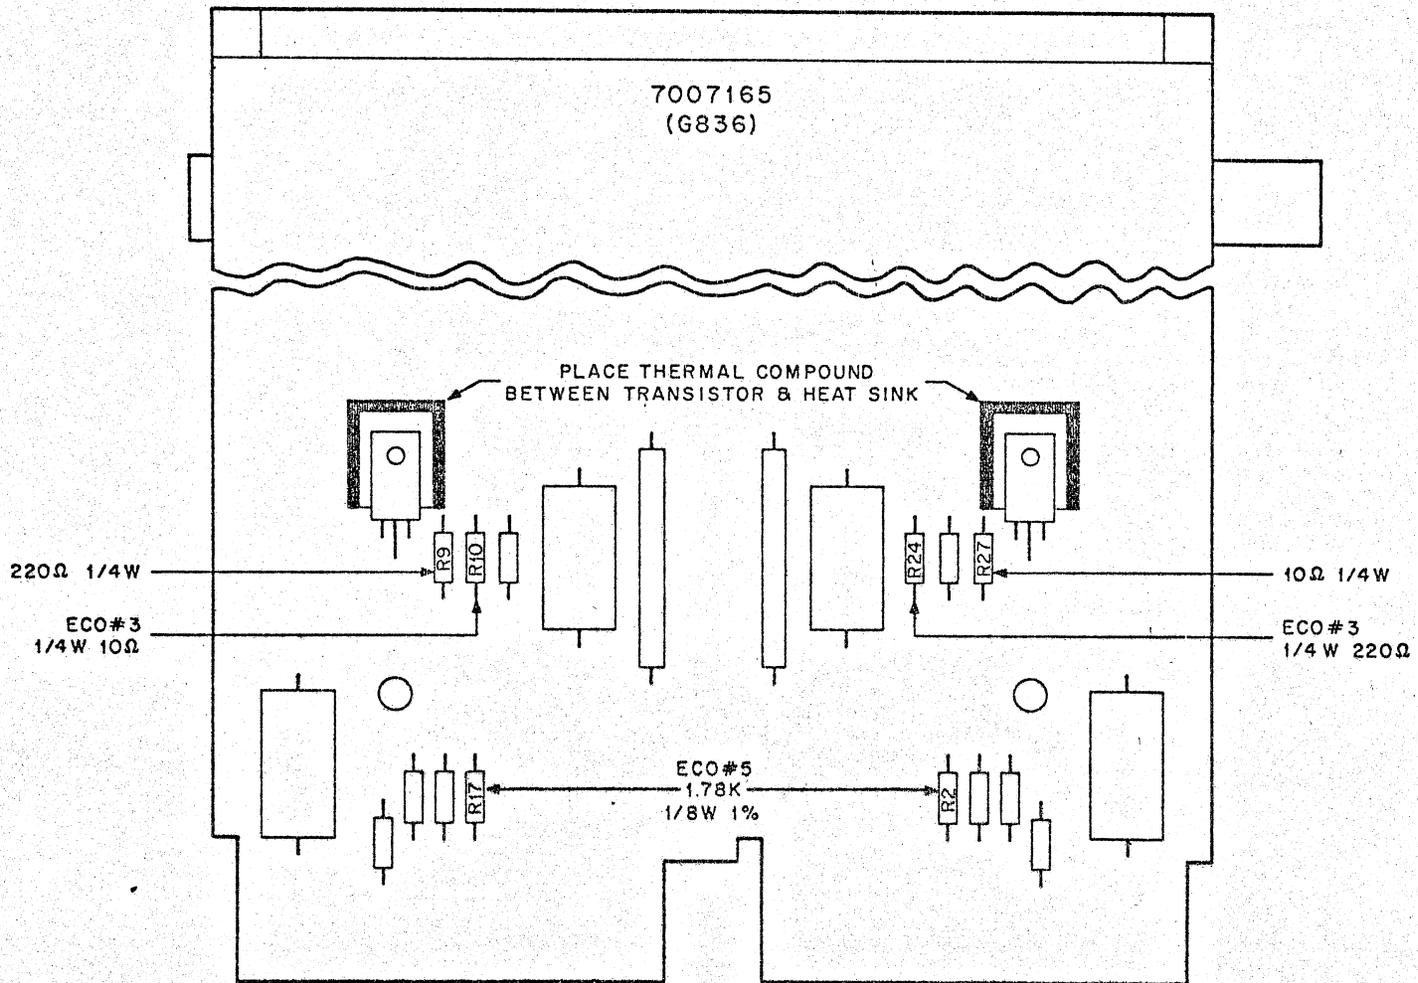
Figure 1 7007165 Power Regulator Assembly

4. Check the G836 regulator card on the 7007165 to ensure all ECOs have been incorporated (See Figure 1).
 - a. R9 and R24 should be 220Ω , not 1K.
 - b. R10 and R27 should be 10Ω , not 150Ω .
 - c. R2 and R17 should be 1.78K, 1% resistor, not 1.62K, 1%. This lowers the +24V to +22V.

Note that ECO #G836-5 (see Figure 1) changes the value of resistors $\pm 23/5V$ to $\pm 21.5V$, thereby reducing the deflection heating.

5. If power supply voltages drift or wander, change Q2 (2N4920), or Q4 (2N4923), E1 (709), and E2 (709) or obtain a new 7007165 regulator. Make certain that the board (G836) in the new regulator is *revision D* or higher. Reworked revision B boards with a decal are acceptable. Make certain that the A225 boards have ECOs 2, 4, 5, and 6 incorporated (Figure 2).

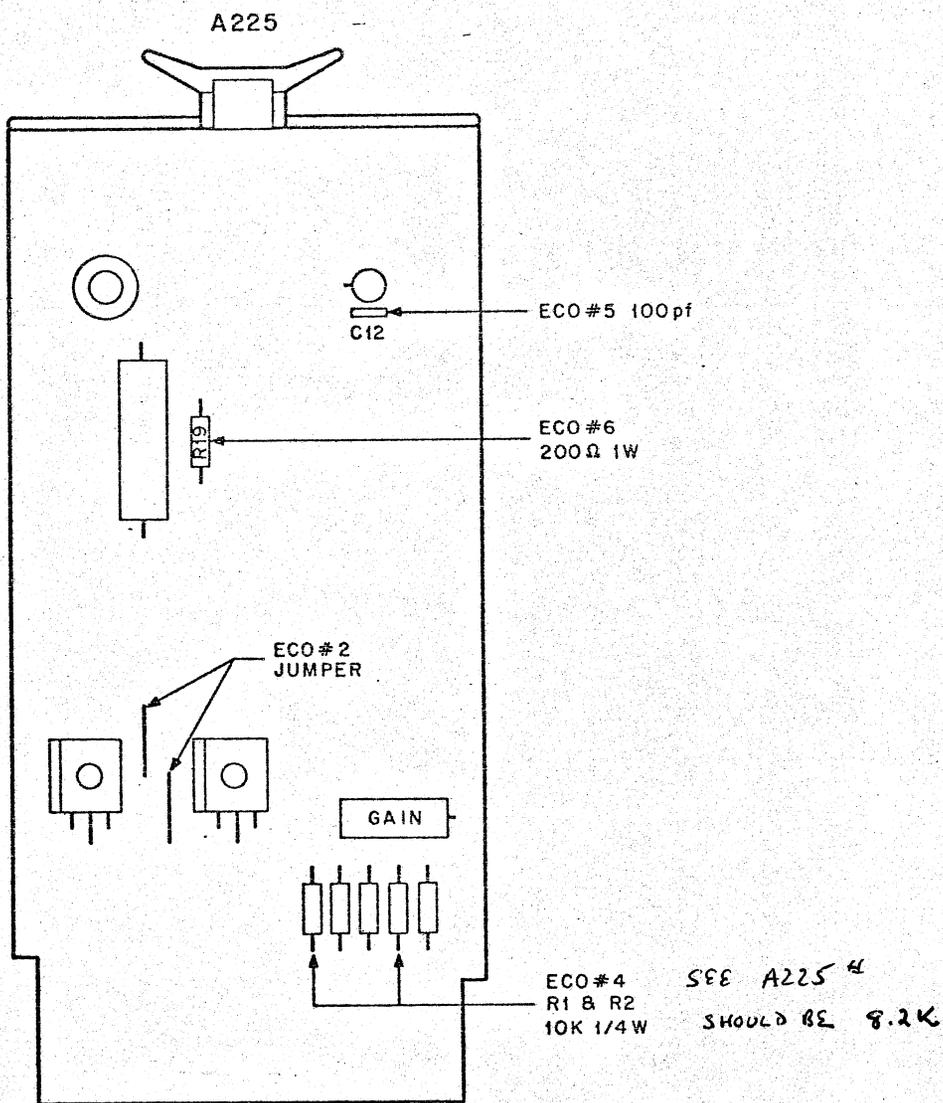
Figure 2 A225 D/A Converter

- ECO #2 R29 and R30 (22Ω) replaced by wires (Reduces runaway)
 ECO #4 R1 and R2 are 10K 1/4W. (Reduces gain sensitivity)
 ECO #5 C12 is 100 pf. (Prevents internal oscillations)
 ECO #6 R19 is 200Ω 1W. (Prevents internal latchup)

Make certain that resistor R19 on the A225 is 200 Ω rather than 270 Ω (see Figure 2). The resistor was changed by ECO #A225-6 to prevent a latch-up problem.

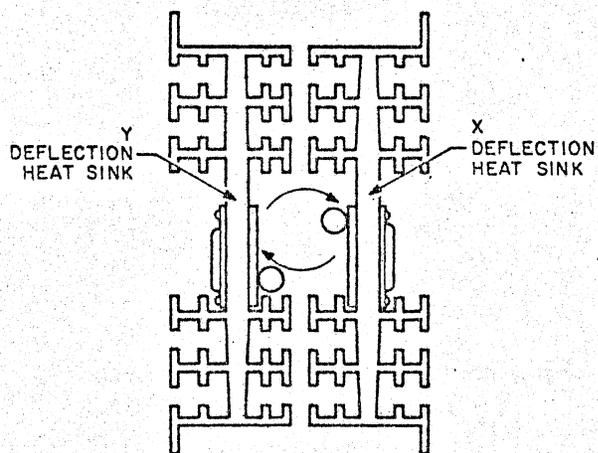
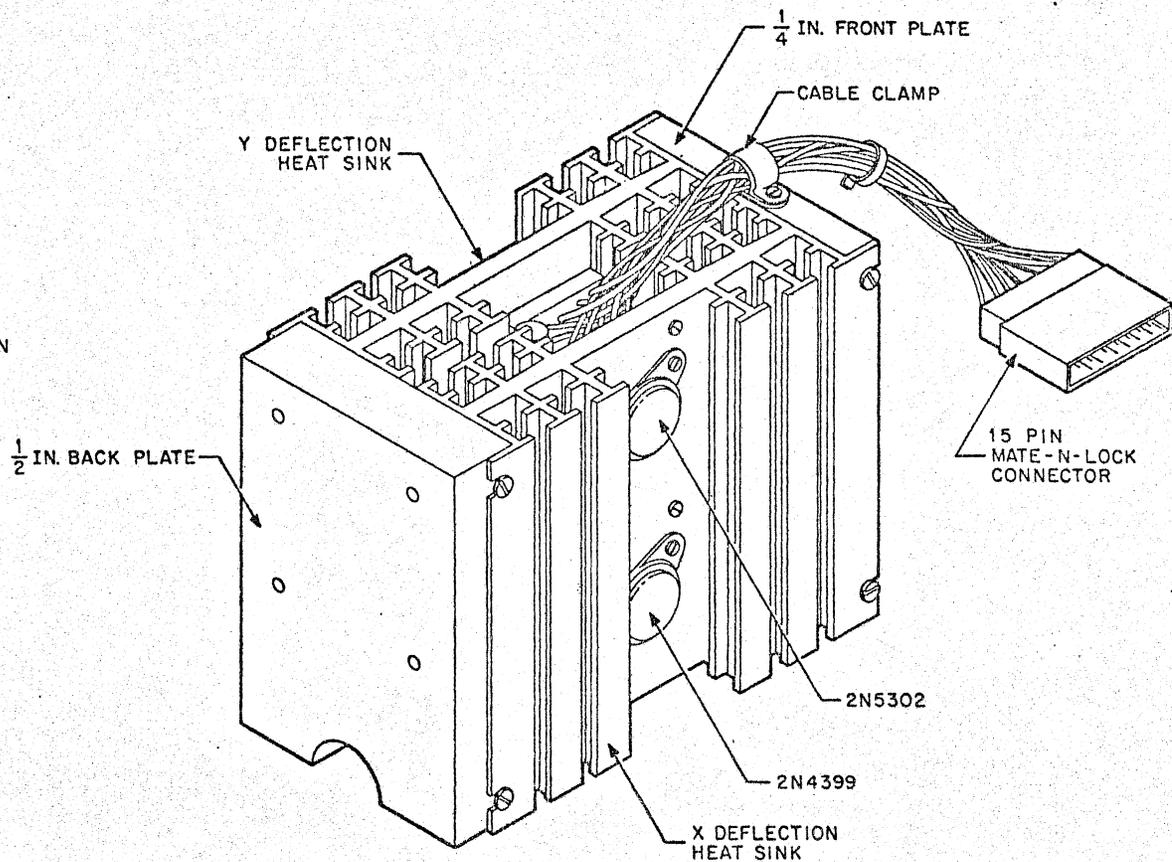
Figure 3 Deflection Heat Sink

6. In order to increase heat dissipation for the power transistors, ECO #VR14-15 must be installed. This ECO consists of physically interchanging the inside section (X) of the deflection heat sink assembly with the outside section (Y). This is done because the outside section receives better air flow. Since X generates more heat than Y, X requires more cooling air.

The interchange is accomplished by unscrewing the end plates of the heat sink assembly, exchanging the heat sinks so that X heat sink is on the outside, and then replacing the end plates.

Before reassembly, remove the thermal cutout on the X heat sink and replace it with a 6-32 screw to hold the terminals on the inside. Place a jumper plug across the thermal cutout leads because the cutout is no longer used and the line circuit must be completed.

1. Remove deflection heat sink assembly from the VR14.
2. Remove 6-32 X 3/8 screw that secures cable clamp to 1/4-inch front plate.
3. Remove eight 6-32 X 1/4 screws that secure X and Y heat sinks to front and back plates.

4. Remove thermal cutout from X deflection heat sink and place a 6-32 X 1/2 pan head screw in the hole.
5. Place 1/2-inch back plate on a flat surface with the two mounting screws (used for securing heat sink) facing up and half-circle cutout facing the bottom.

6. Secure the X deflection heat sink (identified by grey wire on transistor collectors) to the 1/2-inch back plate, using two 6-32 X 1/4 screws. Make certain the 2N4399 transistor is on the bottom.

7. Place 1/4-inch mounting block on other side of the X deflection heat sink with the cable clamp screw hole facing the top. Secure with two 6-32 X 1/4 screws.

8. Secure the Y deflection heat sink (identified by violet wire on transistor collectors) to the opposite side of the assembly, ensuring that the 2N4399 is on the bottom.

9. Secure the cables from X and Y deflection heat sinks to the top of the 1/4-inch front plate with cable clamp and 6-32 X 3/8 screws.
10. To complete the AC line circuit, place a jumper plug (7007006-3) in the 2-pin connector that was connected to the plug for the thermal cutout.

11. Replace deflection heat sink assembly in the VR14.

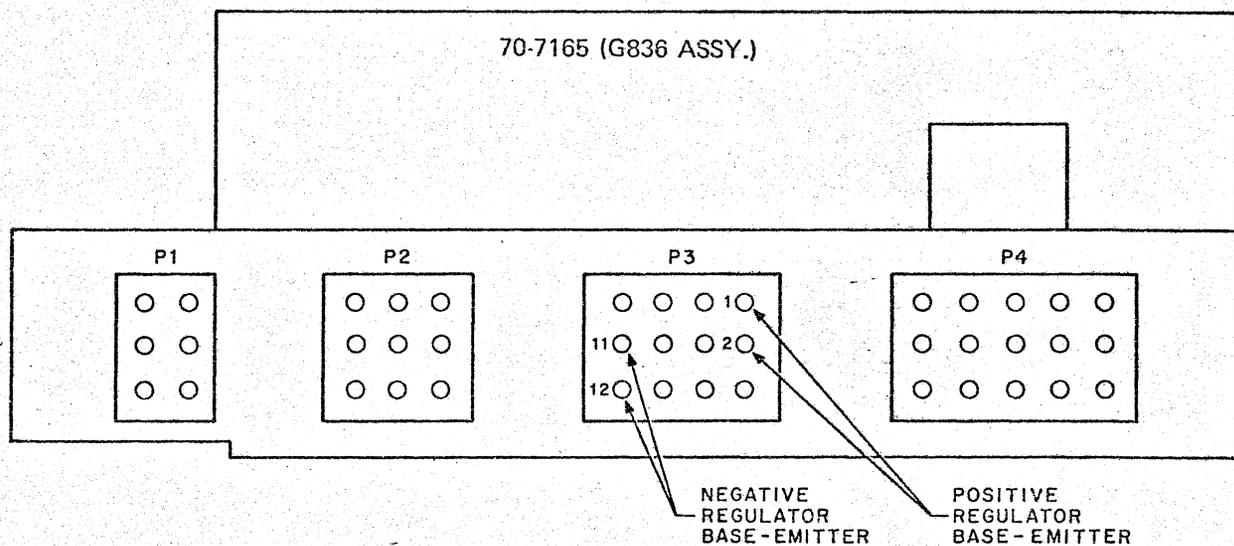
Figure 4 Base-Emitter Voltage Drop, Test Point Location

12. Refer to Figure 4. Measure the base-emitter voltage drop in the power supply heat sink assembly. Because only the positive supply is being used, it should indicate full drop, 1.2V, while the negative supply should indicate only standby drop 0.5V. If the positive supply measurement indicates 2.4V base-to-emitter drop, then one of the 2N4399 transistors is open. Replace both 2N4399 transistors!

13. While measuring the appropriate yoke return, adjust the position potentiometers on the X and Y deflection boards for -2.5V and -2.0V deflection (upper right corner deflection). Then, again measure the base-emitter voltage drop for the negative supply. It should then be 1.2V and the base-emitter drop for the positive supply should be 0.5V. Return the position potentiometers to their original values.
