FAILURE OF THE CHURCH ROCK TAILINGS DAM

by
John D. Nelson¹ and Joseph D. Kane²

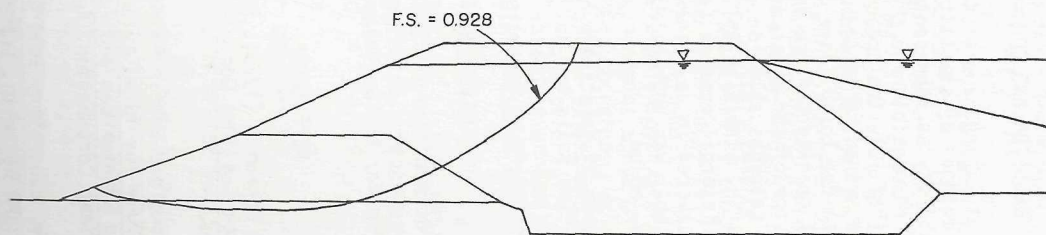
- Analyses that adopted the effective stress shear strength parameters listed in Table 1. As shown in Fig. 1, this analysis assumed essentially complete saturation of the downstream slope from the pond level that existed just prior to failure. This conservatively assumed level of saturation attempted to allow for the effect of extensive cracking. The critical failure circle as shown in Fig. 1 for these conditions reflected a factor of safety less than unity.

Figure 1. Critical Circle for High Phreatic Surface, Church Rock Tailings Dam.

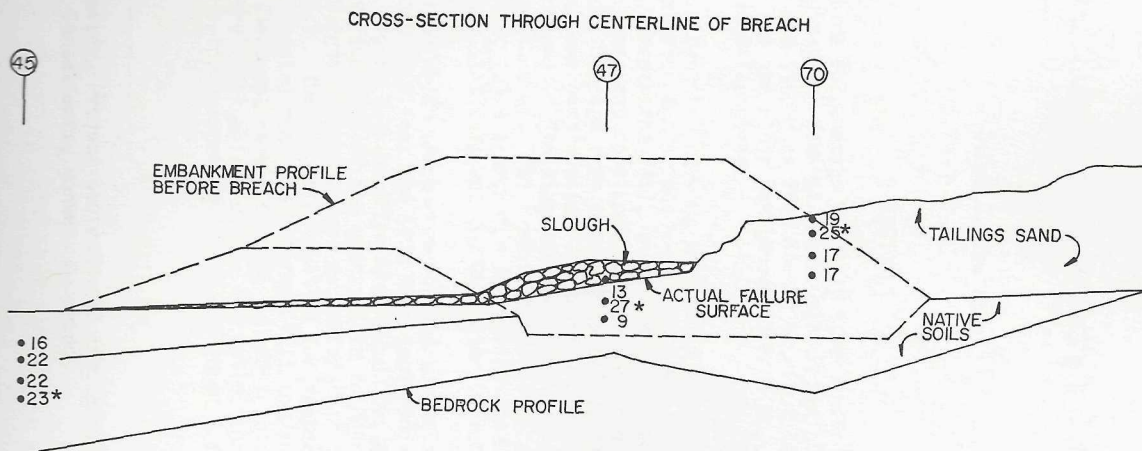
- On the basis of field investigation and the test pit logs completed after the breach, the cross-section of the breach and the actual final failure surface was located by the owner's consultants (Ref. 4) as shown in Fig. 2. Also shown in Fig. 2 are several water content readings taken from borings in the vicinity of the breach. The water content values marked by asterisk in Fig. 2 indicate that a zone of unusually high water content extended from the upstream side of the embankment down to the downstream toe. This zone of high water content exists in close proximity to the proposed actual failure surface. Analysis using the effective stress shear strength parameters listed in Table 1 and the failure surface shown in Fig. 2 indicated a factor of safety of approximately 2 for even a relatively high phreatic surface. It is not expected, therefore, that a general shear failure would have occurred along that entire plane.

were conducted on samples taken from the zone of high water content as shown on Fig. 2. The lowest shear strength that was measured indicated an undrained strength of about 300 lb/ft². Other tests indicated an undrained strength of about 900 lb/ft². In this third variation of stability analysis, it was considered that conditions represented by the UU tests were more appropriate for the collapsing type soils following the period of initial wetting. Wedge type stability analyses were conducted assuming that a longitudinal crack formed the upstream boundary of the active wedge and the crack was filled with water. For various assumed positions of longitudinal cracks, factors of safety less than unity were computed assuming an undrained shear strength of 300 lb/ft². Thus, it is evident that after cracking of the embankment and introduction of tailings water into the cracks, instability of the downstream toe of the embankment could result.

Figure 2. Actual Failure Surface after Breach (after Sergent, Hauskins and Beckwith).
