The BP Deepwater Oil Spill - Why Top Kill May Have Failed and Monday Open Thread 2

Posted by [Heading Out](#) on May 31, 2010 - 4:15pm

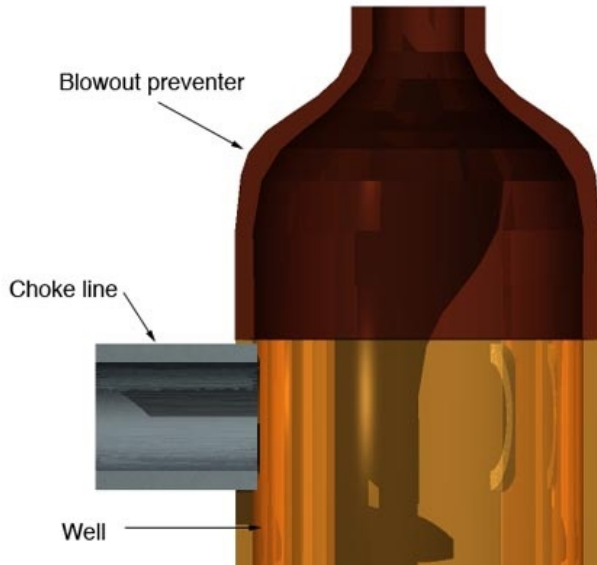
Simple approximation of the situation

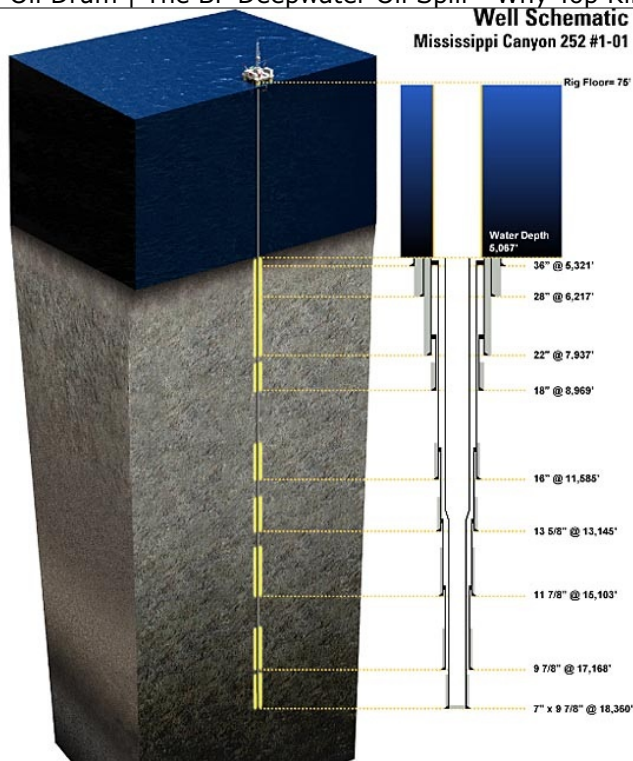
Casing and cement down the Deepwater well

BP do not know, but believe that the oil is getting into the well through the cement wall at the bottom of the well, and probably rising up the well through the empty space (annulus) between the production casing and the outer lining of the well. However the oil and gas may have broken through the bottom of the cement plug and be rising up within the production casing, in which it is also rising through the DP once the oil reaches its lower end. It could also reach the bottom of the DP by flowing up the annulus then go down the production casing to the bottom of the DP and then back up into the BOP.

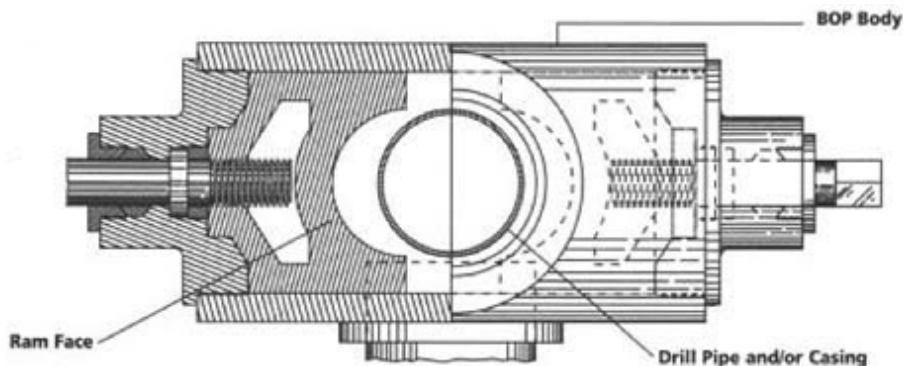
MO BOP in the fully open position. The ram faces are retracted back, away from the pipe in the bore.

BOP open allowing flow through the annulus ([ASME](#))

BOP closed against the pipe, sealing the annulus ([ASME](#))

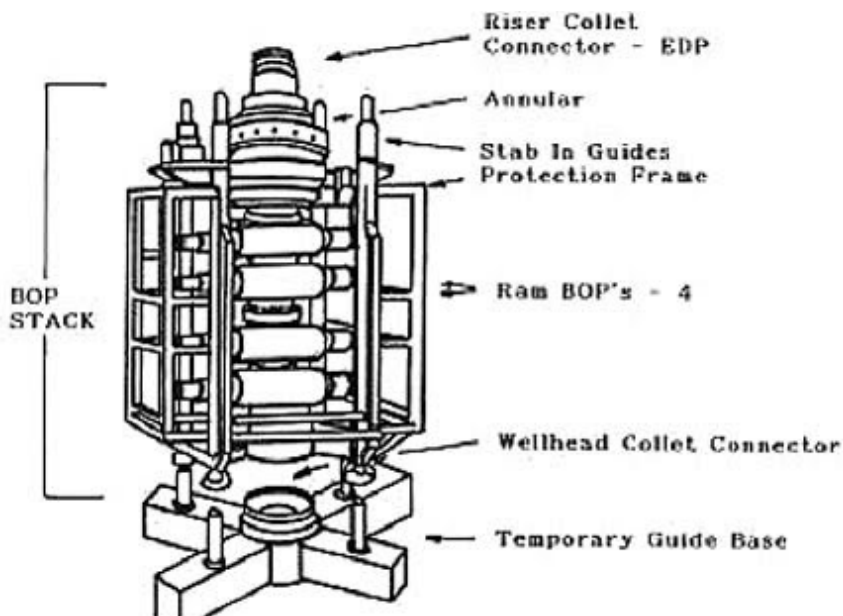
BOP connection to casing at the seabed ([PCCI report for MMS](#))

The problem that this leaves, in the current situation, is that the pipe that runs through these two seals is open at the bottom to the oil flow. So how can the flow through this be stopped?
