The BP Deepwater Oil Spill - Why Top Kill May Have Failed and Monday Open Thread 2

Posted by [Heading Out](#) on May 31, 2010 - 4:15pm

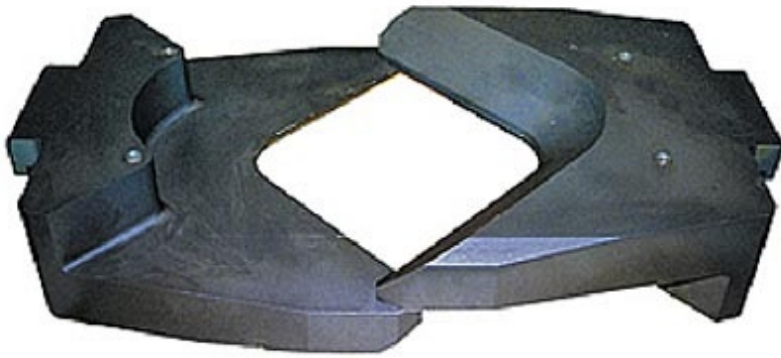
Shear blades to cut through the DP and seal the well ([Varco](#))

The DP should shear, but would be held in place by the grip of the annular sealing rams below.

In this case it seems to be recognized that for some reason this shear event did not totally succeed. Thus the pipe was not totally severed and the two shear plates did not fully move over one another to complete the seal.

One could also, once the bent riser and pipe had been cut, go in down the pipe bit that extends up, go down past the annular seals with an abrasive jet lance (most of the flow is around the DP as we have established above) and cut it off, right above the shears. Then partially open the shears, drop the pipe out, and close them again. If they move all the way closed, without the obstruction, then the well may be sealed.

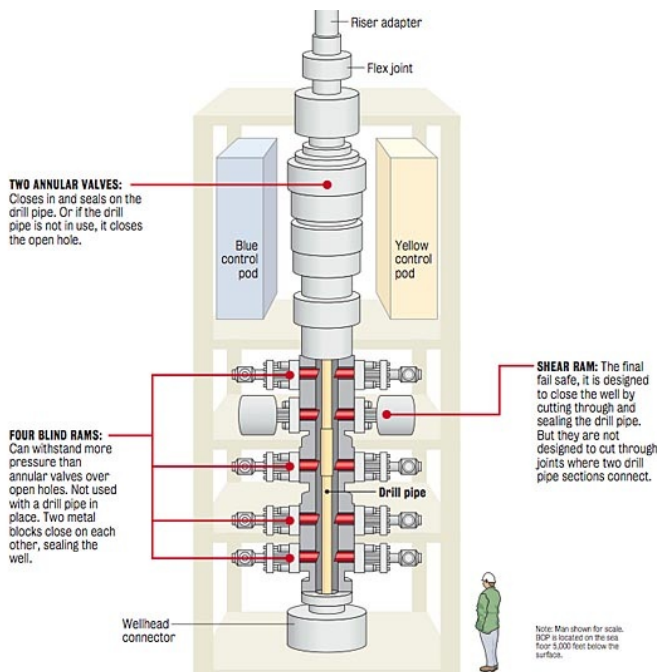
Now this is where the problem arises, because, in part, that pipe is still open at its lower end. If the leak is around the outside of the pipe, through a gap that has generated between the pipe and the annular seals, then the use of the junk shot to fill the cracks and gaps could conventionally have worked. But the configuration of the rams on the Deepwater Horizon had changed from the initial simpler configuration to add seals for occasions where the drill pipe was not in place.

Ram layout on the BOP ([Times Picayune](#))

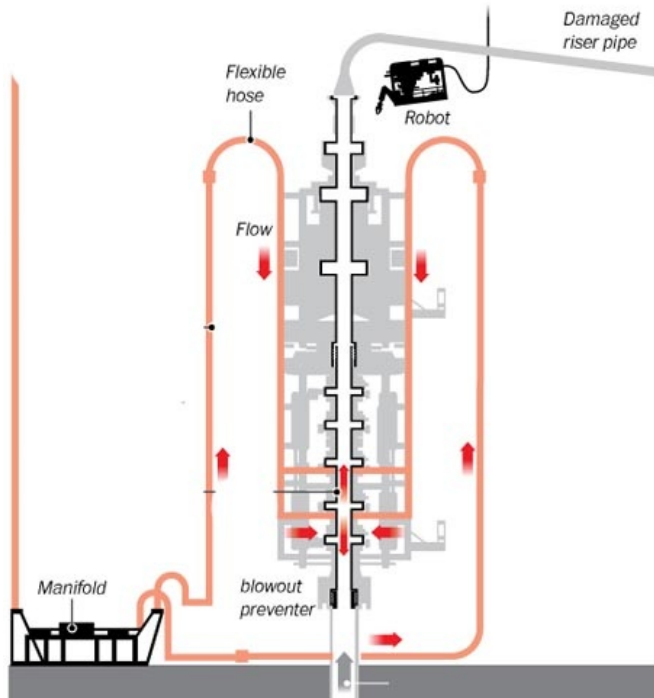
Section through the BOP, showing the anticipated mud flow path (initially from BP)

If the leak is coming up through the remnants of the drill pipe then life is complicated. It can't all be coming up through an undamaged pipe alone, since it was the far open end of that which was successfully closed at the beginning of the remedial steps, but if it is coming through the pipe and leaking out at the shear rams into the annulus that feeds into the riser, and out to the sea, then putting sealing particles into the bottom of the BOP to seal the cracks could have sealed some of the leakage around the DP trapped in the shears, but not that flowing through the shears in the remaining pipe section.

The reason that it can't is that the access to that flow is occurring 3,367 ft below the riser, and there is no easy way to get the sealing particles down that far. If they are mixed with mud and pushed down the well to that level and then released they have a different problem. The hope when they were released into the well was that the flow of the current would be enough to carry them up to the cracks that they could seal. But if they have to be carried down to the zone where the oil remains, then their density may be sufficiently high that they get into the flow without enough speed to lift them up into the BOP, instead it will cause them to sink to the bottom of the well.
