XLI. *An Account of the Effects of Lightning in St. Bride's Church, Fleet-street, on the 18th of June 1764: In a Letter to Mr. Benjamin Wilson, F. R. S. from Edward Delaval Esq; F. R. S.*

Read June 28, 1764. **T**HE inclosed is an account of the effects of the lightning on the steeple and spire of St. Bride's church, with drawings [TAB. XIV. XV.] which very accurately express the parts damaged by it.

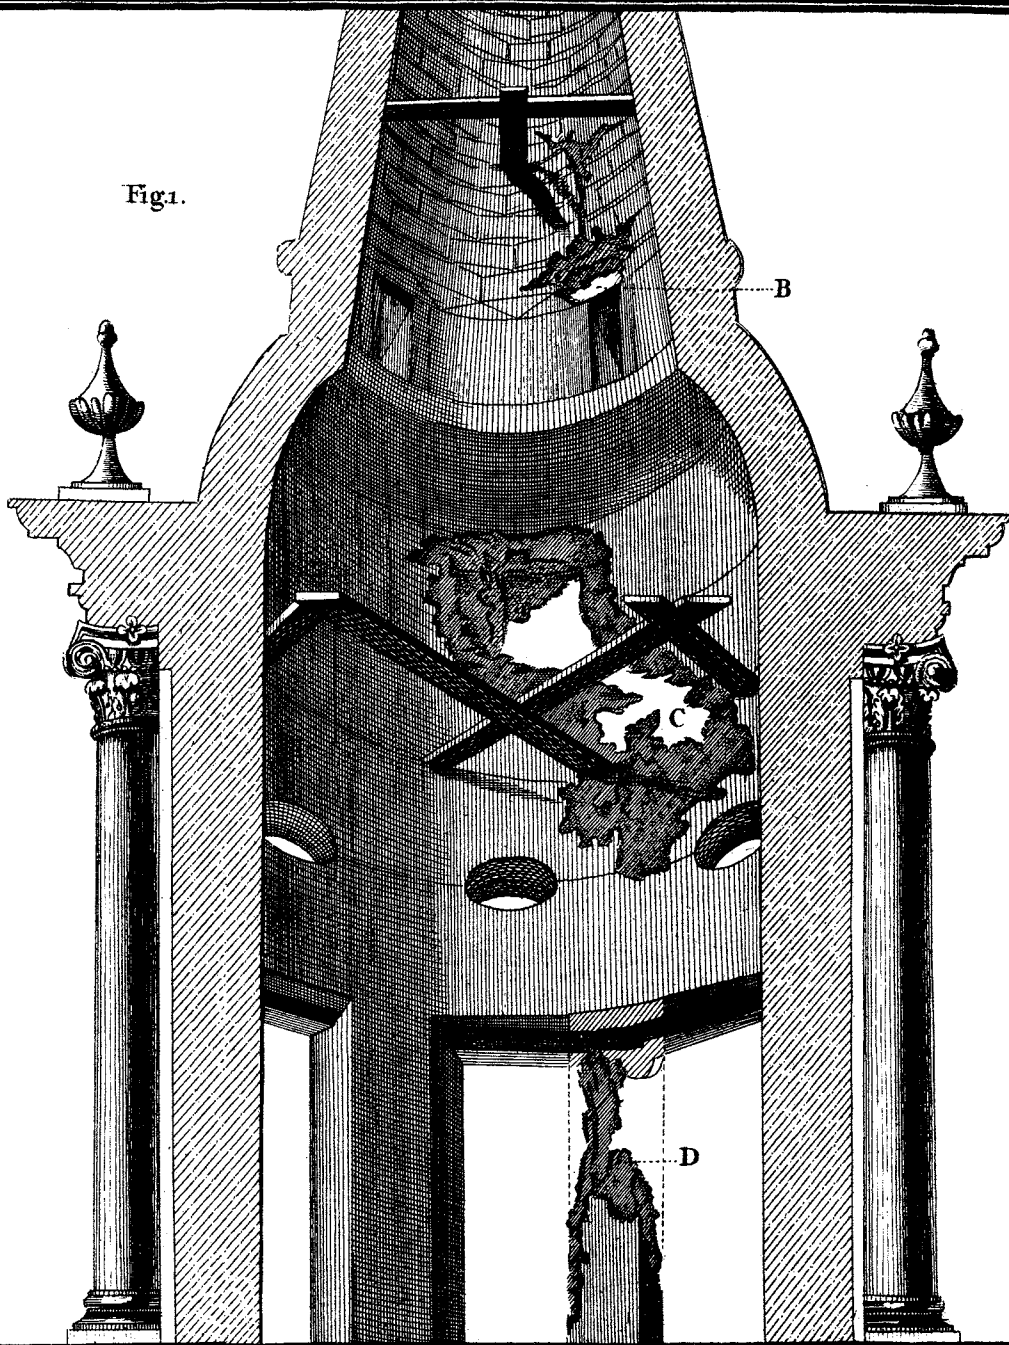
Fig. 1.

At this place the first marks of it are seen: at H the top of the copper cross, which is the highest part of the building, the gilding is by the explosion partly torn off and partly discoloured, so as to differ remarkably from the rest of the cross where the gilding is very well preserved. Some small pieces of solder are melted; and all this part appears as if it had been exposed to the fire.

The lightning seems to have entered here, and to have been conducted as low as the hole at A, by an iron spindle twenty feet in length, and two inches in diameter; of which ten feet were surrounded by the copper ball, vane and cross; and the lower half was inclosed in a groove cut through the middle of the solid stones which composed the upper part of the spire, and rested at A on the bottom of that groove, which was sunk five inches deep into the lowest of those solid stones: this last mentioned stone being three feet broad and one deep. The interval between the sides of the spindle and the groove made to receive it was filled up by melted lead poured in between them.

The lightning accumulated in the metal, having its passage towards the earth strongly resisted at this place, has in expanding itself formed the hole A, by burst-

bursting off from the lower part of the spindle the stones contiguous to it on that side.

At each of the angles of the metal, the stone on which it rested is cracked, which probably was occasioned by the lightning issuing with greater freedom from those parts, than from the flat surface.

From hence, as low as to the corniche B, it seems to have been conducted along the surface of the spire, which was wetted by the rain that had fallen in the morning, before the lightning: and having been accumulated in the iron bars B and C, in discharging itself from them, it has made the greatest explosion at this place.

On examining the inside of the steeple beginning from the top, the first effect of the lightning that appears is a hole in the stone work at B, beginning immediately above an iron bar which served to support the top of the window or opening, and running upwards towards the two cross iron bars: this, when viewed from the outside of the church, is seen to have spread round most of the lower part of the spire, so that it seems in great danger of falling.

The next stroke is about four feet below: at this place four iron bars lie horizontally across the spire, and are tied together by chain bars which are inclosed in the stonework: where the end of one of the cross bars is inserted in the stone, the lightning has burst open the hole described at C, and, when the same is viewed at the outside, a great part of the cornice appears to be broken off.

At D, where the two iron bars serving to support the top of the windows meet and are joined together, the lightning accumulated in them has broken off the pier by which they were inclosed.

At E, an iron bar N°. 1. about twenty five inches long, was inclosed nine inches deep in the stonework of the pier, separating the East arch from the arch next it towards the North: the end of this bar joins at a right angle another bar, N°. 2, which is laid across the arch. The lightning accumulated in the iron (N°. 1.) which was inclosed in the stonework, has burst off all the stone that surrounded it, and part of the pier adjoining. The flaw is continued downwards, as expressed in the drawing, meeting with smaller iron cramps in it's way.

At F, the next arch lying immediately under the last mentioned one, an iron was inclosed in the stone in the same manner as the bar at N°. 1. The stone is torn off from this iron exactly in the same manner as at N°. 1: but the damage has not reached much further than the stone which was contiguous to and covered this bar. At the bottom of this arch the fill stone, which covered some cramps of iron, is torn off from it's place.

At G, the next arch under this, the force of the lightning seems to have been much diminished, a small part of one stone only being broken.

It is evident that these effects would have been prevented, if a sufficiently large metallic conductor had been extended from the metal at the top of the spire down to the earth, communicating with the other metallic parts of the building that lay in its way.

I think, a conductor of metal less than six or eight inches in breadth, and a quarter of an inch in thickness (or an equal quantity of metal in any other form that may be found more convenient) cannot with safety be depended on, where buildings are exposed to the reception of so great a quantity of lightning. These are the only points in which I have ventured to differ from Dr. Franklyn.
