**Accident
survenu le 6 novembre 2002
en approche de l'aéroport
de Luxembourg
au Fokker 50
immatriculé LX-LGB
exploité par Luxair**

*Accident
occurred on November 6, 2002,
on approach to
Luxembourg Airport
to the Fokker 50
registered LX-LGB
operated by Luxair*

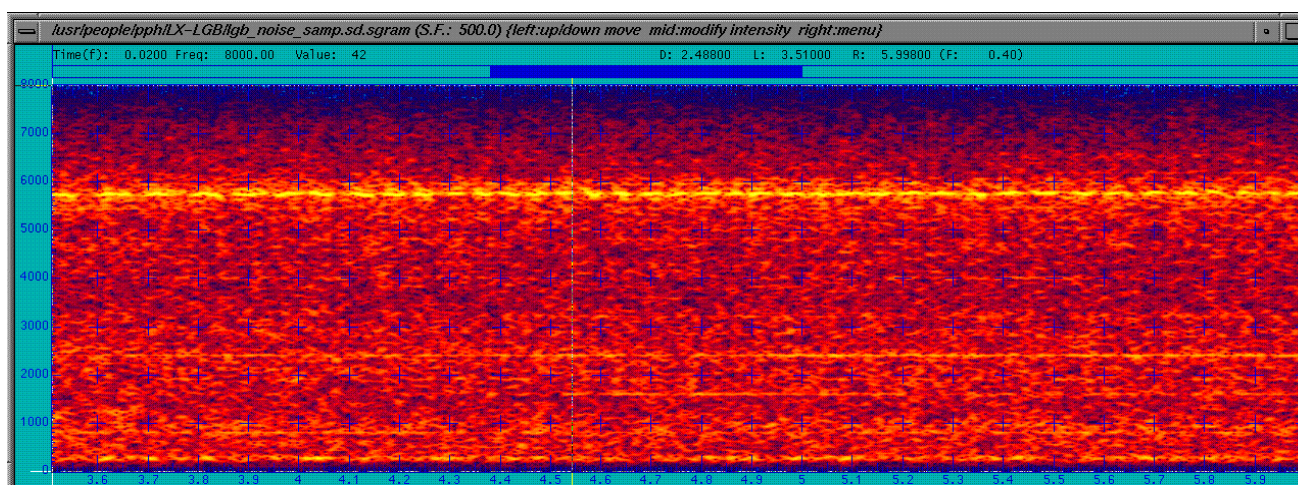
Fig. 1: Représentation Temps – Fréquence du bruit de fond du LX-LGB en vol. Time – Frequency representation of the background noise on LX-LGB in flight.

Comme l'illustrent les deux figures précédentes, le LX-LGB (fig. 1) présente un signal plus bruité que celui du LX-LGC (fig. 2). Les hautes fréquences (autour de 5700 Hz) correspondent au bruit de la turbine de l'avion. Le bruit de fond est globalement plus élevé en raison du bruit aérodynamique caractérisé par un spectre large bande.

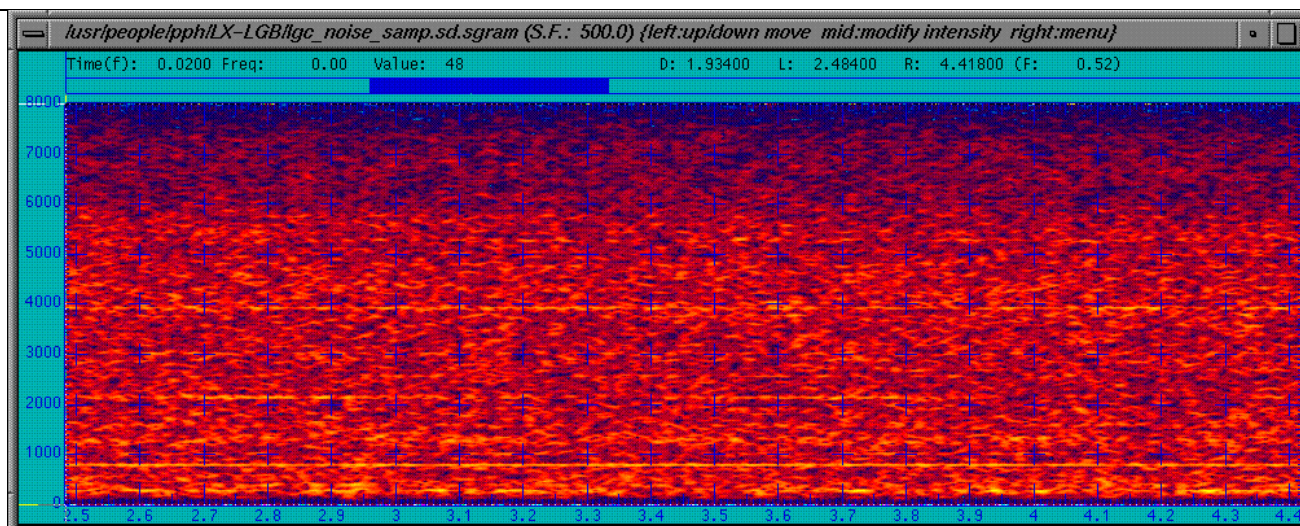
Fig. 2: Représentation Temps – Fréquence du bruit de fond du LX-LGC au sol. Time – Frequency representation of the background noise on LX-LGC on the ground.

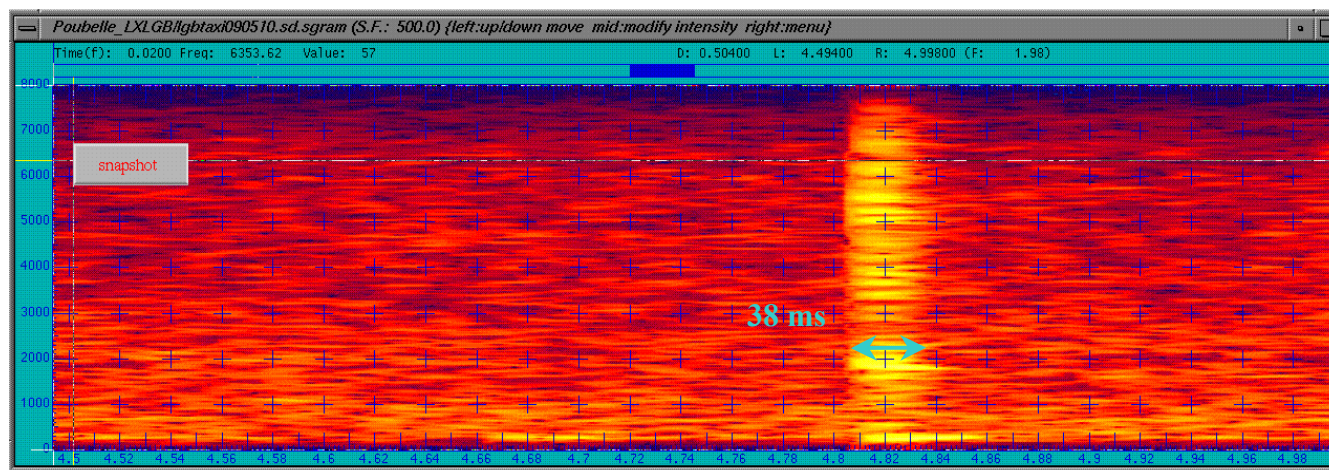
Fig. 3: *Représentation Temps – Fréquence du bruit transcrit. Time – Frequency representation of the transcribed noise.*

La figure ci-dessus représente le bruit enregistré sur le CVR de l'accident et transcrit comme l'activation des taxi lights. La figure suivante représente un enregistrement du bruit généré par l'activation des taxi lights lors des essais au sol.

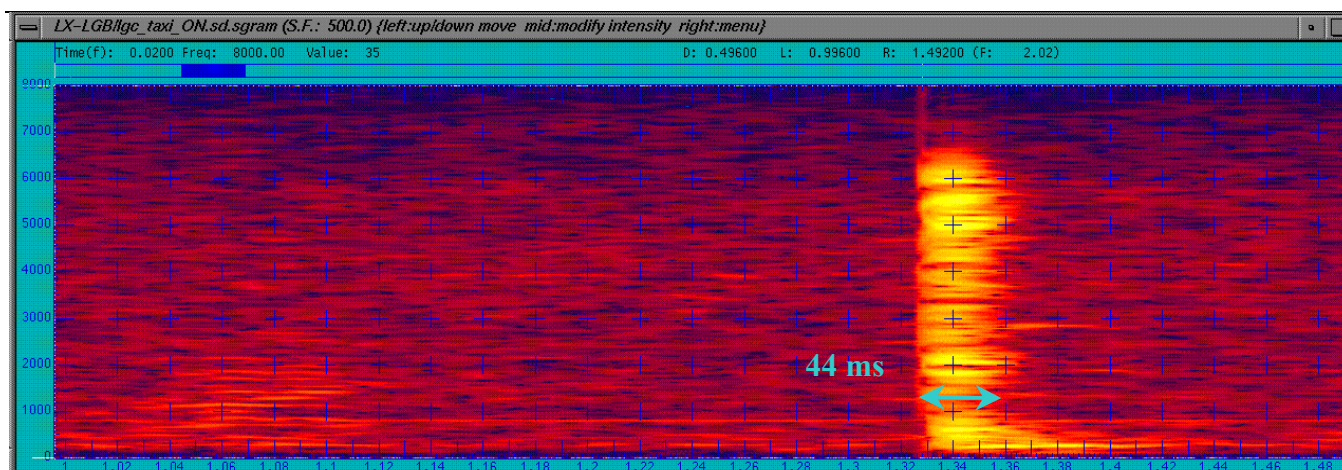
Fig. 4: Représentation Temps-Fréquence du bruit généré. **Time – Frequency representation of the generated noise.**

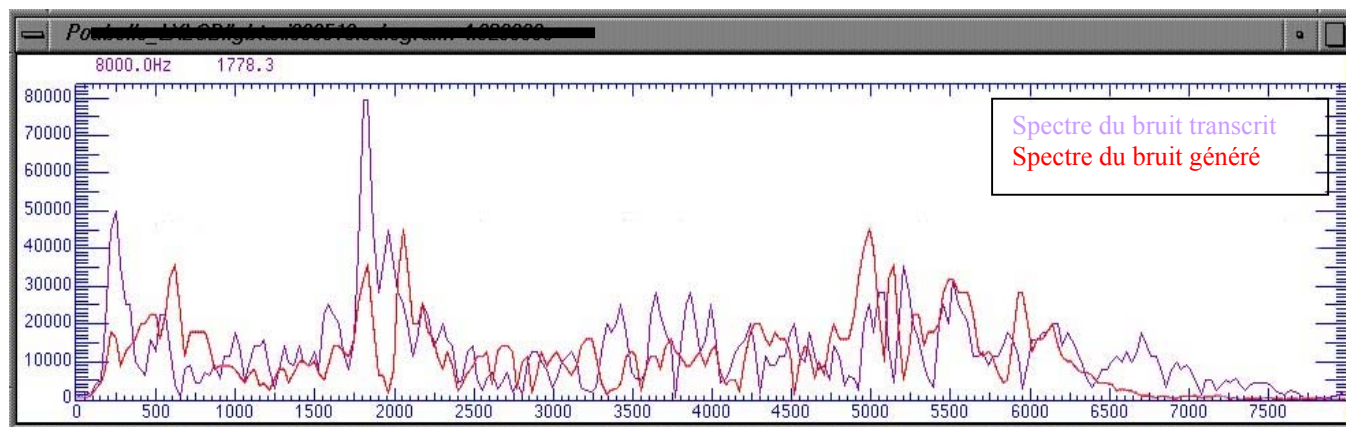
Fig. 5: Comparaison des composantes fréquentielles des bruits transcrit (en mauve) et généré (en rouge). **Spectrum comparison between the transcribed noise (in mauve) and the generated noise (in red)**

On retrouve les mêmes composantes fréquentielles, notamment aux basses fréquences et autour de **2000** et **5000** Hz.

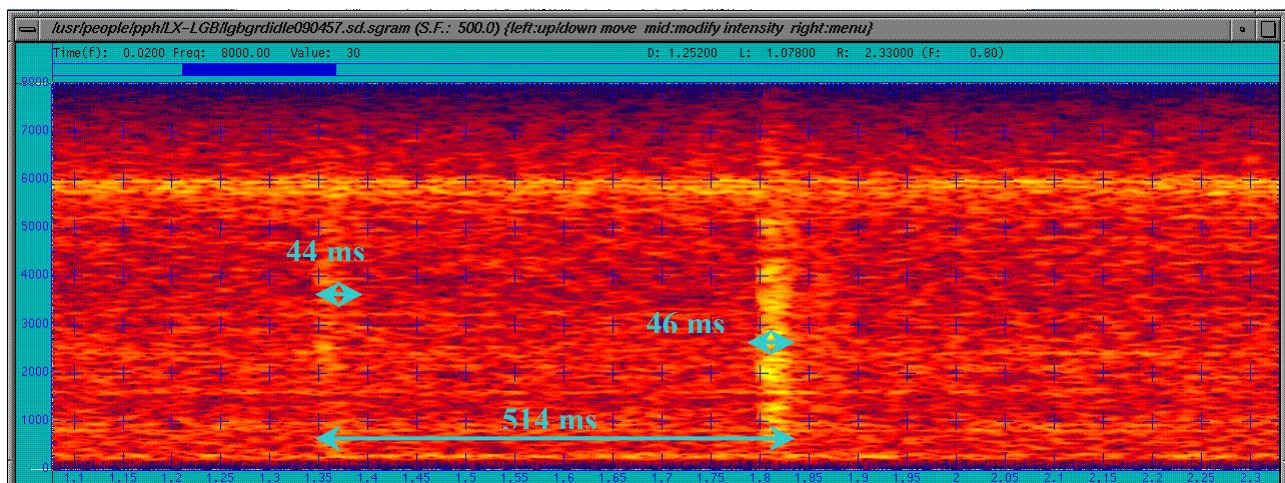
09 h 04 min 58 s : "Bruit de sélecteur similaire au déplacement du Ground Idle Stop" / "Sound similar to the operation of the Ground Idle Stop Selector"

Fig. 6: Représentation Temps – Fréquence du bruit transcrit. Time – Frequency representation of the transcribed noise.

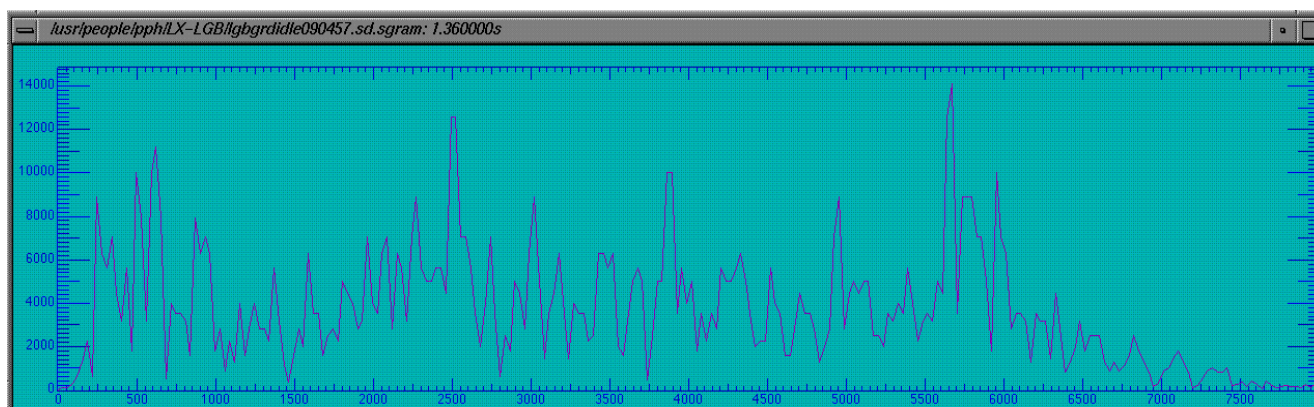
Fig. 8: Représentation Fréquentielle du bruit à identifier. Frequency representation of the noise to be identified.

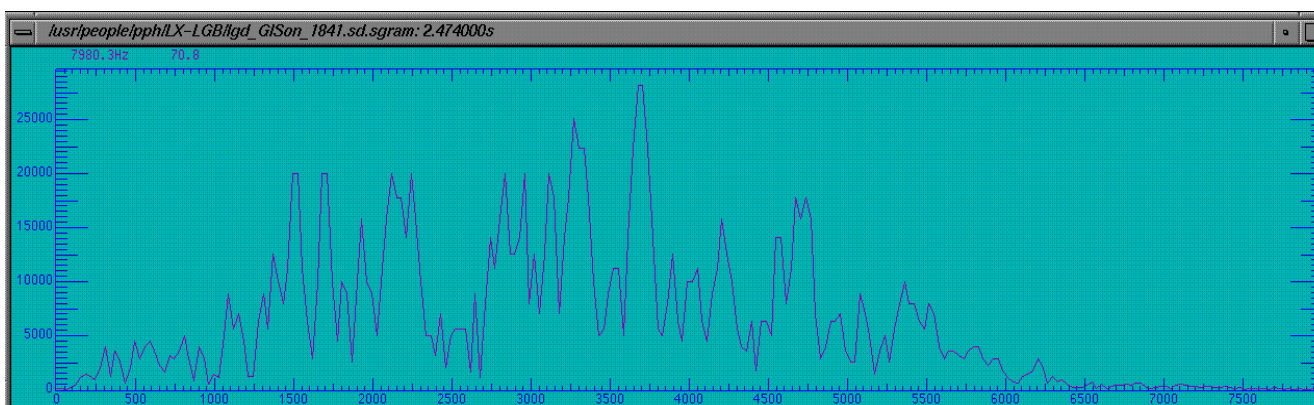
Fig. 9: Représentation Fréquentielle du bruit généré. Frequency representation of the generated noise.

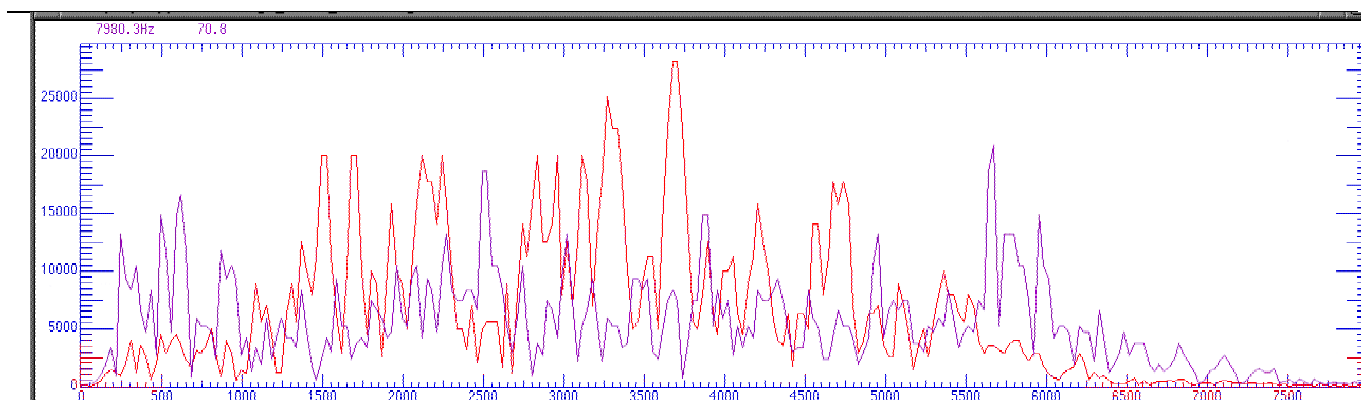
Fig. 9bis : Comparaison des composantes fréquentielles des bruits transcrit (en mauve) et généré (en rouge). Spectrum comparison between the transcribed noise (in mauve) and the generated noise (in red)

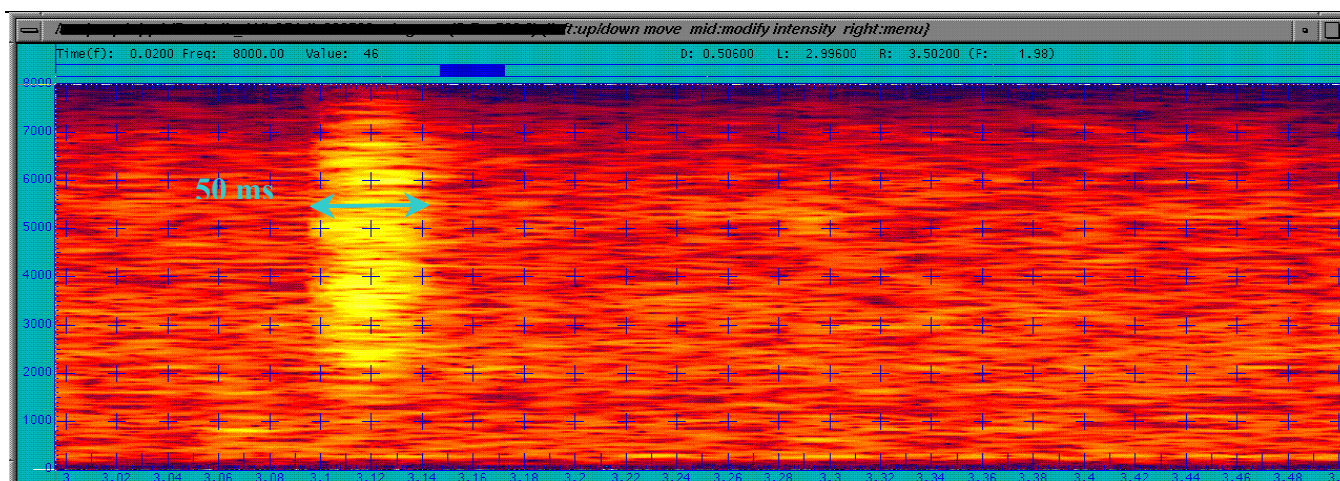
Fig. 10: Représentation Temps – Fréquence du bruit transcrit. Time – Frequency representation of the transcribed noise.

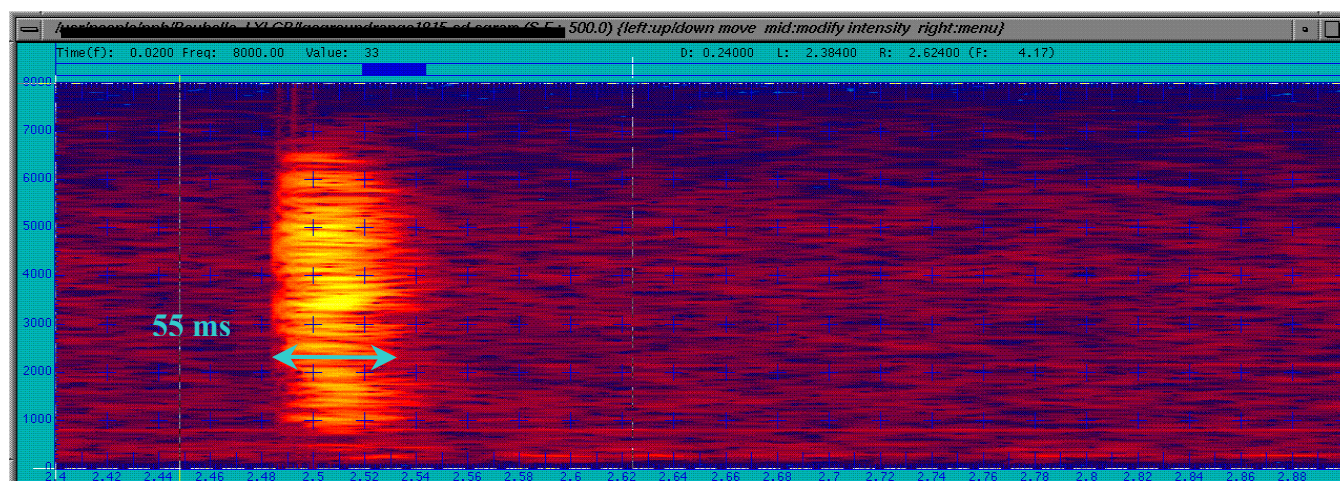
Fig. 11: Représentation Temps-Fréquence du bruit généré. Time – Frequency representation of the generated noise.

La figure ci-dessus représente le bruit du déplacement des *Ground Range Selector* dans le domaine temps - fréquence dans le cas où les deux leviers sont soulevés simultanément afin de retrouver une forme semblable à celle obtenue avec le bruit transcrit.

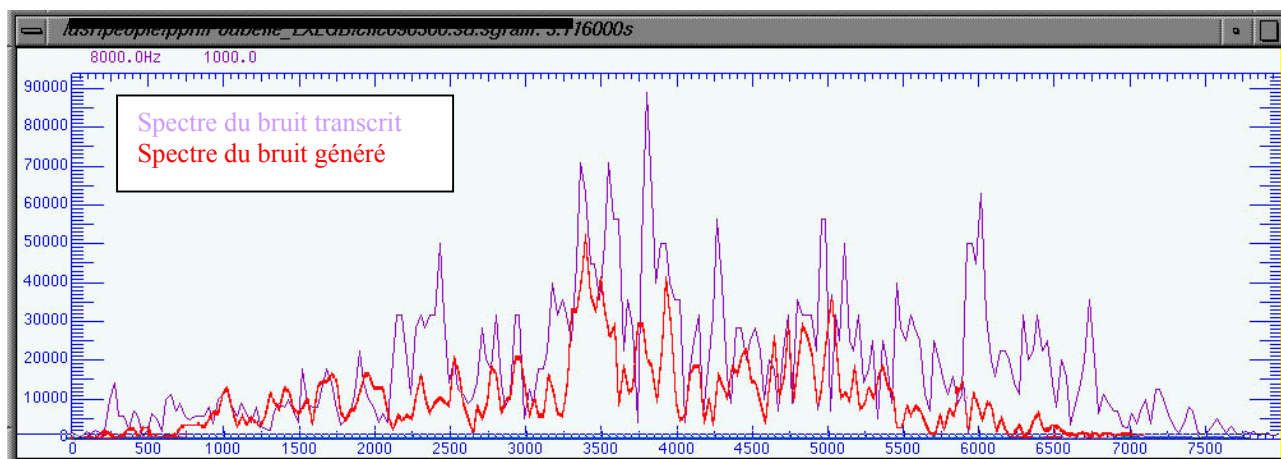
Fig. 12: Comparaison des composantes fréquentielles des bruits transcrit (en mauve) et généré (en rouge). Spectrum comparison between the transcribed noise (in mauve) and the generated noise (in red)

La figure ci-dessus est une superposition des représentations fréquentielles du bruit transcrit et du bruit généré. Les intensités du spectre du bruit transcrit apparaissent logiquement supérieures à celles du bruit généré (voir paragraphe 3.2 *Environnement sonore / Acoustic environment*). On constate ainsi que les deux spectres sont très proches. On rappelle que les pics entre 5500 et 6000 Hz proviennent du fonctionnement du turbopropulseur.

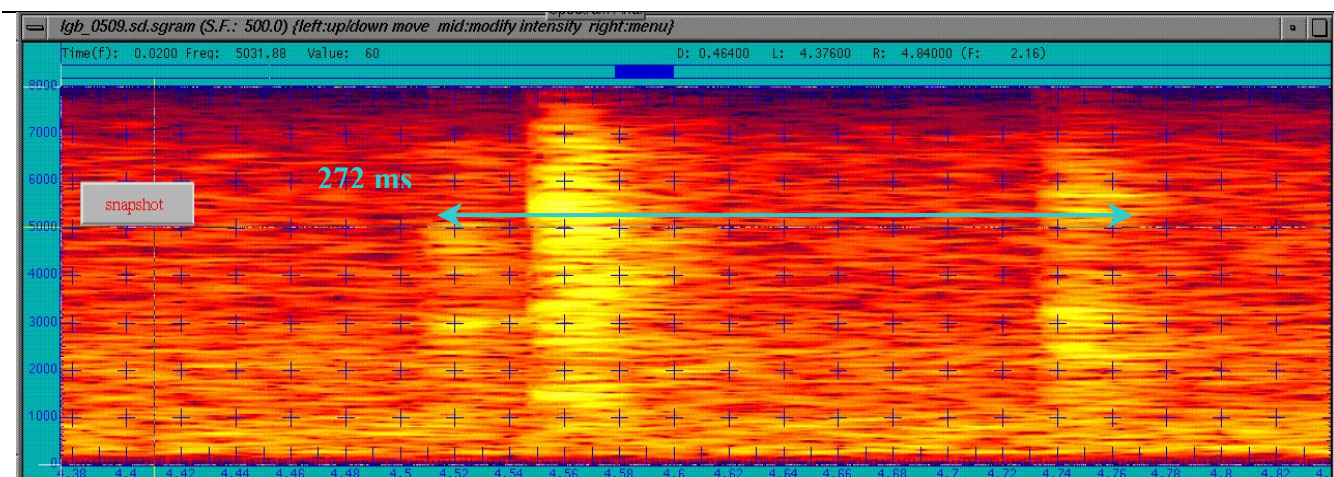
This noise occurs as the crew members talk about the flaps position. After this communication and this noise, the FDR data show that the flaps extended to ten degrees.

Fig. 13: Représentation Temps – Fréquence du bruit transcrit. Time – Frequency representation of the transcribed noise.

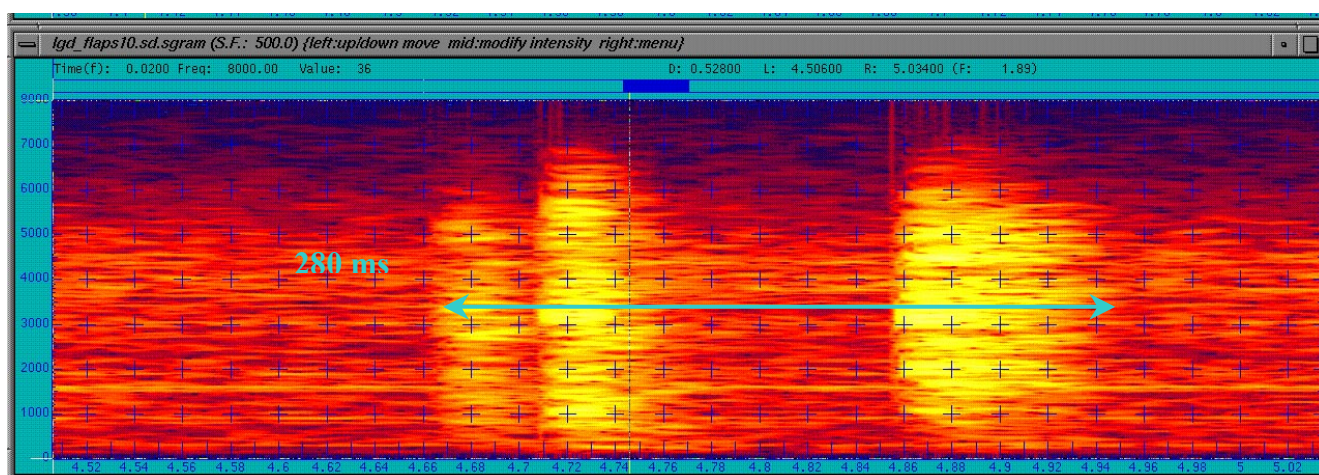
Fig. 14: Représentation Temps-Fréquence du bruit généré. Time – Frequency representation of the generated noise.

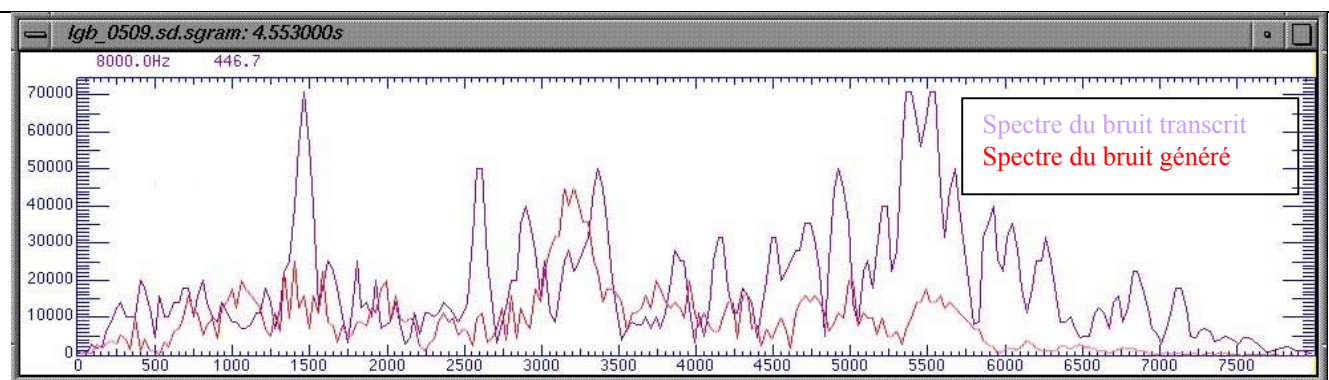
Fig. 15: Comparaison des composantes fréquentielles des bruits transcrit (en mauve) et généré (en rouge). **Spectrum comparison between the transcribed noise (in mauve) and the generated noise (in red)**

Bien que moins évidents, les résultats de la figure ci-dessus permettent de retrouver les points communs entre les deux bruits, notamment autour de **3250, 3800, 5000 et 5500 Hz**.

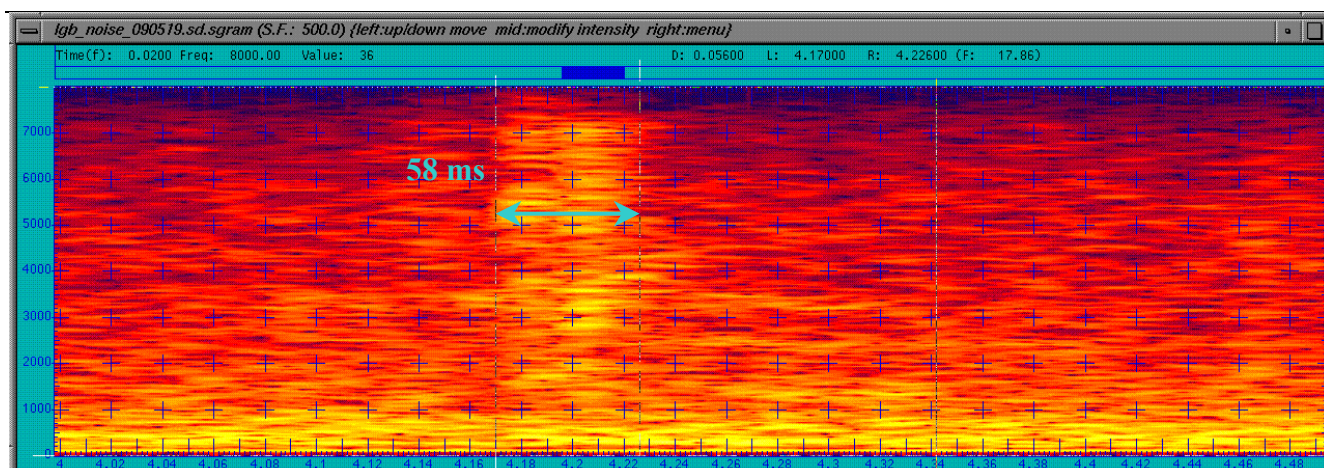
09 h 05 min 19 s : "Bruit" / "Noise"

Fig. 16: *Représentation Temps - Fréquence du bruit à identifier). Time Frequency representation of the noise to be identified.*

Ce bruit peut se décomposer temporellement en deux parties correspondant à deux « clics » distincts mais très rapprochés. Sa durée totale est de **58 ms**.

*This noise can be decomposed temporally in two parts corresponding with two separate but adjacent noises. Its total duration is **58 ms**.*

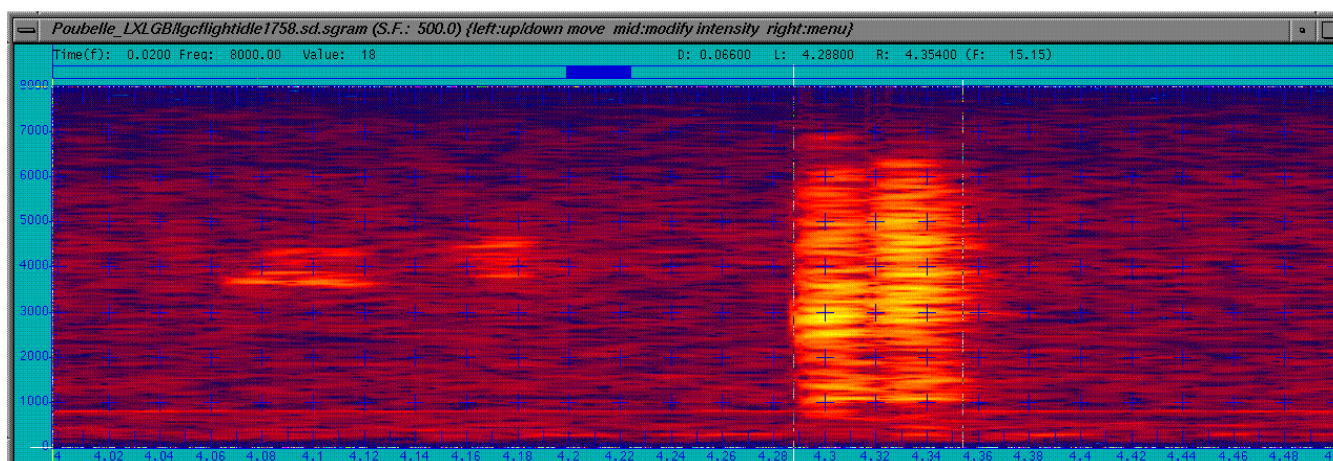
Fig. 17: *Représentation Temps - Fréquence du mouvement de la manette des gaz mise en position « Flight Idle ». Time Frequency representation of the operation of the throttle moved to « Flight Idle » position.*

La figure ci-dessus correspond à la manipulation des manettes des gaz sur le Fokker 50 immatriculé LX-LGC. Ces manettes étant en position *Ground Idle*, elles sont ramenées en position *Flight Idle*. On retrouve ici cette décomposition en deux clics distincts. La durée totale de ce bruit est de **70 ms**.

*The above figure corresponds to the movement of the thrust levers on the Fokker 50 registered LX-LGC. The thrust levers were moved to the Flight Idle position from the Ground Idle position. The same two separate clicks can be seen. The total duration of this noise was **70 ms**.*

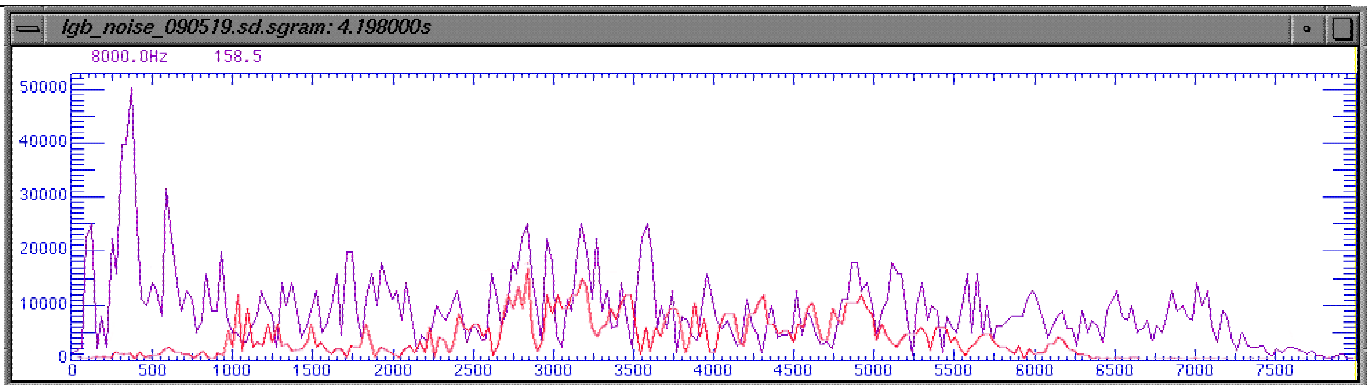
Fig. 18: Comparaison des composantes fréquentielles des bruits transcrit (en mauve) et généré (en rouge).
Spectrum comparison between the transcribed noise (in mauve) and the generated noise (in red)

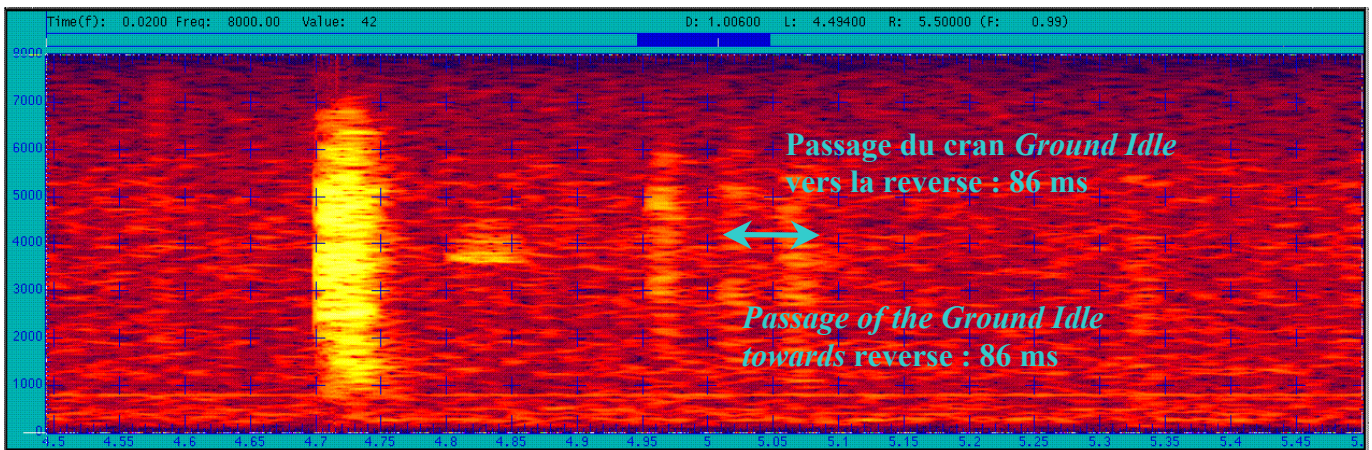
Fig. 19: Représentation Temps - Fréquence issue du mouvement de la manette des gaz mise en position « Reverse » depuis la position *Flight Idle*. **Time Frequency representation of the movement of the throttle from the Flight Idle position to the « Reverse » position.**

La figure ci-dessus illustre tout le mouvement des manettes de gaz de la position *Flight Idle* à la position *Reverse*. Les flèches indiquent le passage du cran *Ground Idle*.

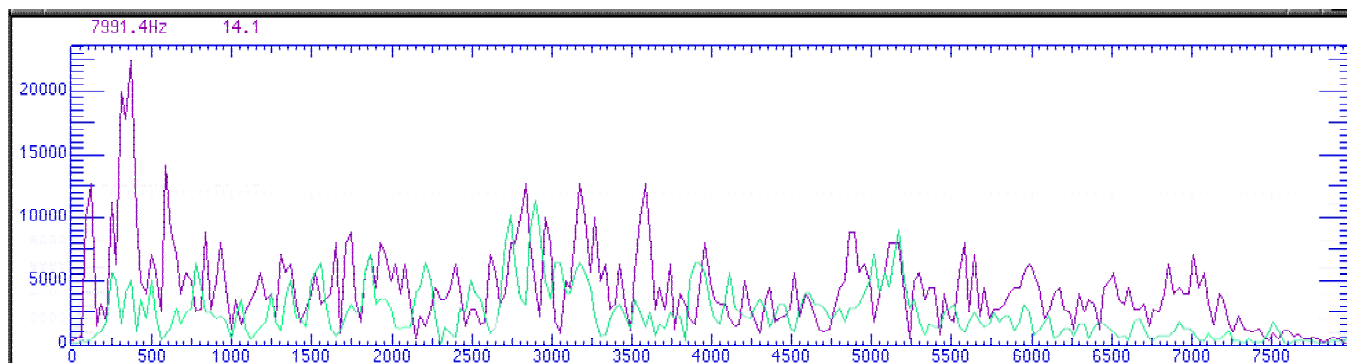
Fig. 20: Comparaison des composantes fréquentielles des bruits transcrit (en mauve) et generé (en vert). **Spectrum comparison between the transcribed (in mauve) and the generated noise (in green)**

Here again, both spectra show similarities around 700, 1500, 3200, 4000 Hz... This is why the two previous noises tested were compared with each other in order to obtain a differential identification. The results in the figure below were thus obtained.

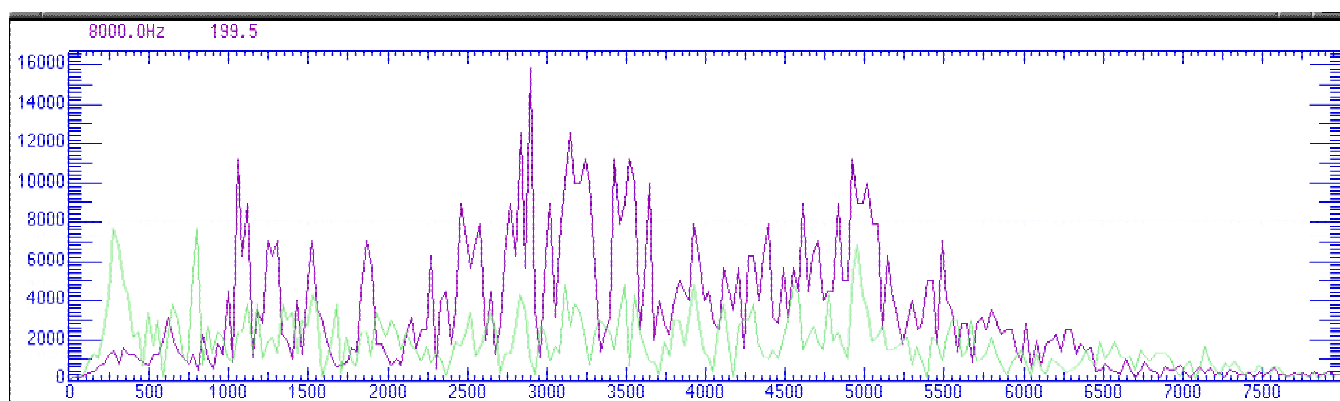
Fig. 21: Comparaison des composantes fréquentielles entre les manettes poussées en position Flight Idle (en mauve) et en reverse (en vert). **Spectrum comparison between the throttle set to Flight Idle position (in mauve) and Reverse position (in green)**

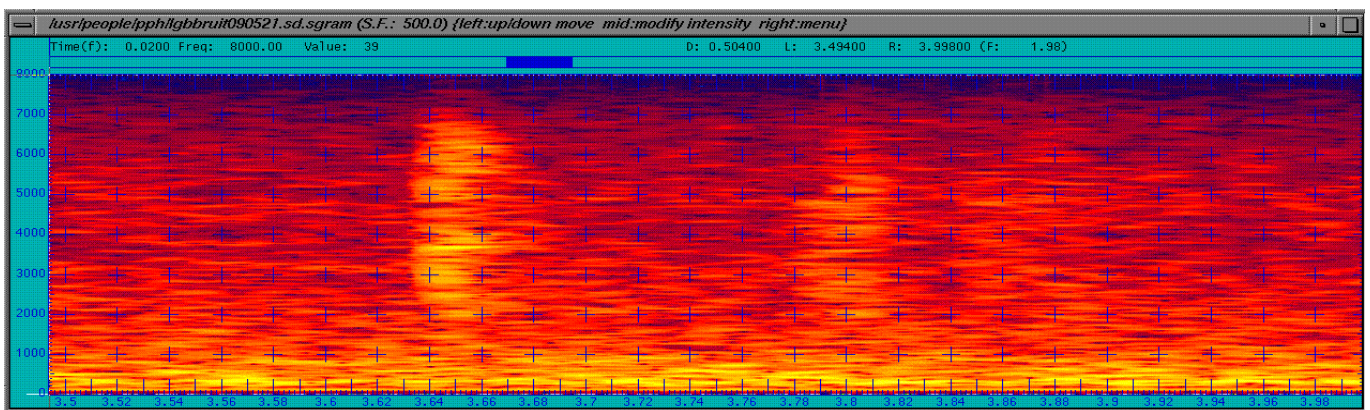
09 h 05 min 21 s : "Bruit similaire à la manoeuvre de la commande des flaps" / "Sound similar to the operation of flaps control"

Fig. 22 : Représentation Temps – Fréquence du bruit. Time – Frequency representation of the noise.

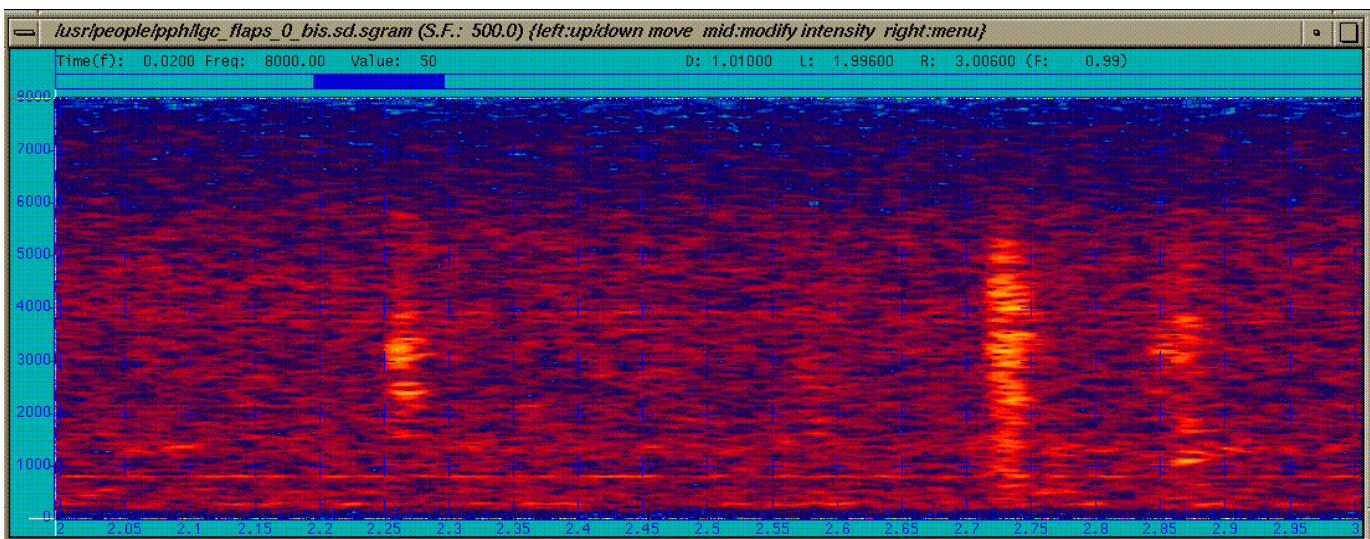
Fig. 23 : Représentation Temps – Fréquence du bruit de la commande des volets ramenée en position 0°. Time – Frequency representation of the flaps command noise moved to 0°.

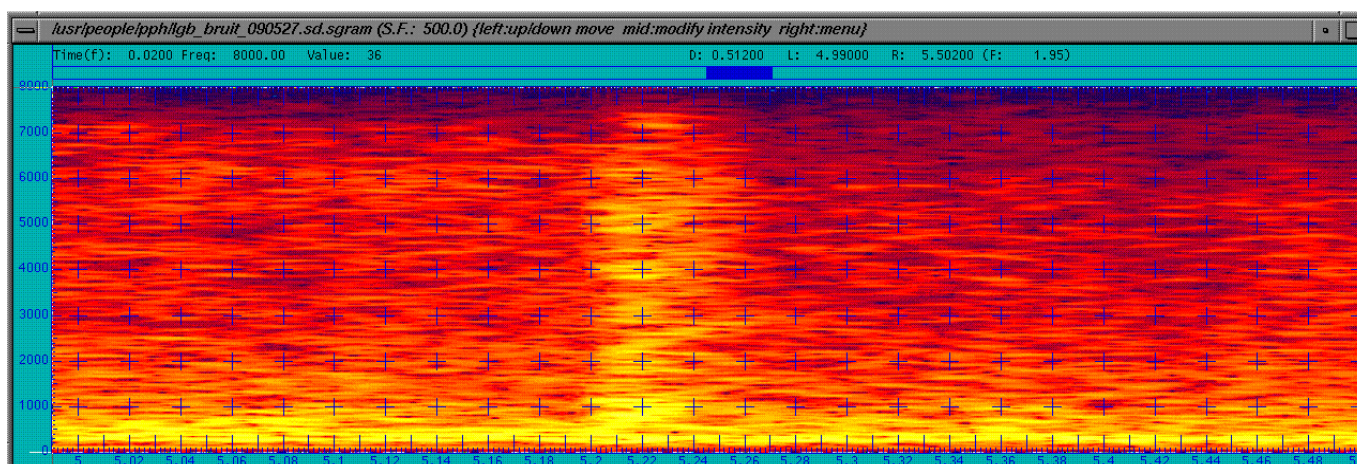
09 h 05 min 27 s : "Bruit" / "Noise"

Fig. 23 : Représentation Temps – Fréquence du bruit. Time – Frequency representation of the noise.

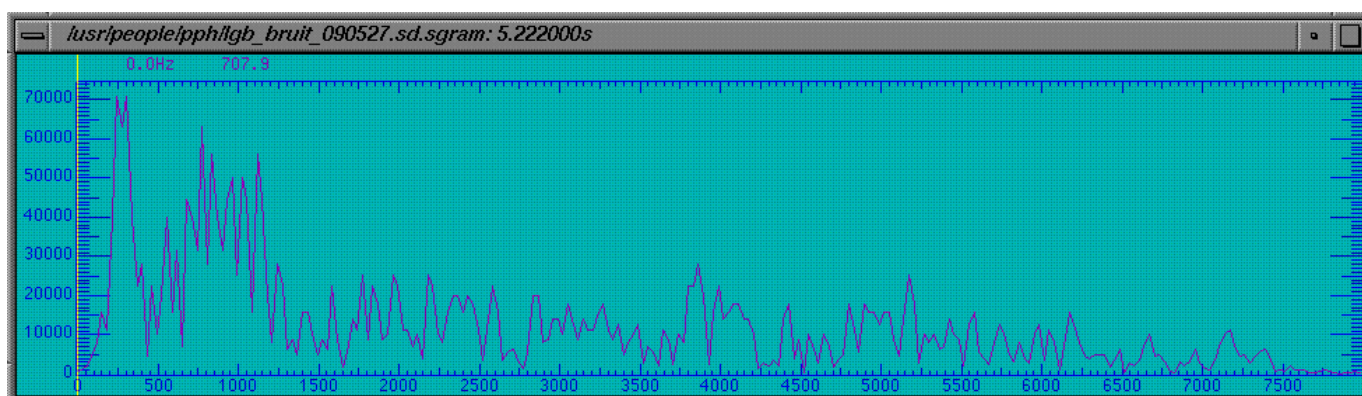
Fig. 24 : Spectre du bruit inconnu. Spectrum of the unidentified noise.
