Power775
Drive (HDD/SSD) Service Procedure
Last Modified 9/28/2011

Power775 Drive (HDD/SSD) Service Procedure
PN: 41U8515, EC N44172

These steps define the procedure to replace a drive in a P7IH cluster.

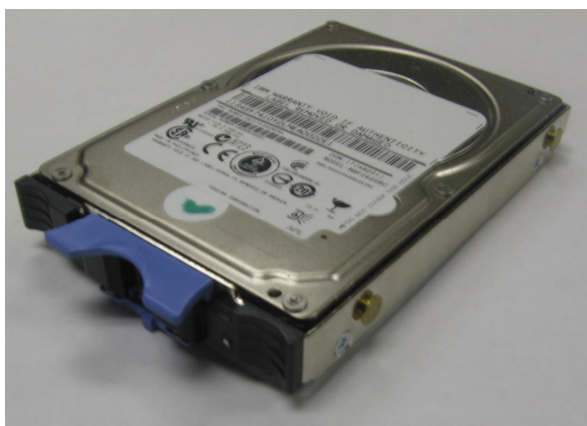
Figure 1 Hard Drive Assembly Photo

- a. A 2.5” Small Form Factor (SFF) Serial Attached SCSI (SAS) Hard Drive Assembly
This will be referred to as “hard drive”. See Figure 1 & 3.
- b. A 2.5” SFF SAS Solid State Drive (SSD) Assembly
This will be referred to as “SSD”. See Figure 2 & 4.

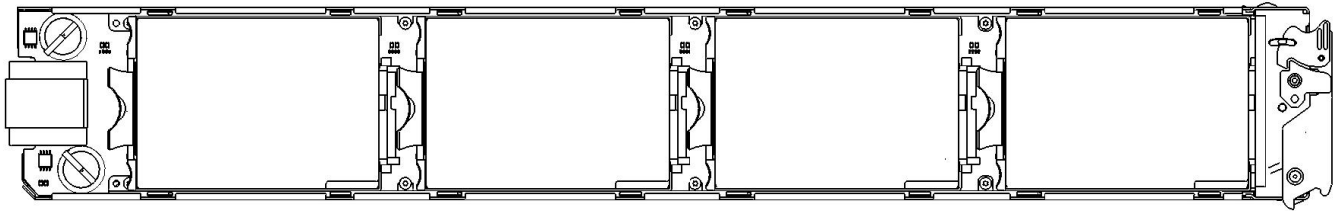
Figure 5 Drive Carrier Drawing

The Drive Carrier is used to hold up to four Drives located (Figures 5,6 and 7).
There are 96 Drive Carriers in the Disk Enclosure (DE) (see Figures 8,9 and 10).

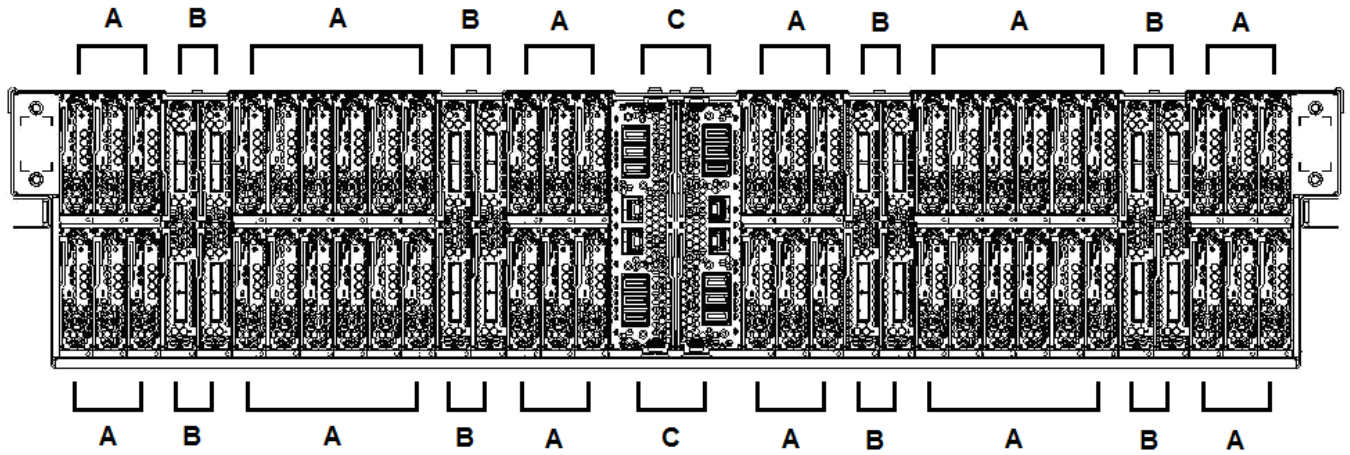
Figure 8 Disk Enclosure (Front View – showing 48 Drive Carriers, 8 Port Cards, and 2 DCCAs)

A = Drive Carrier B = Port Card C = DE DCCA

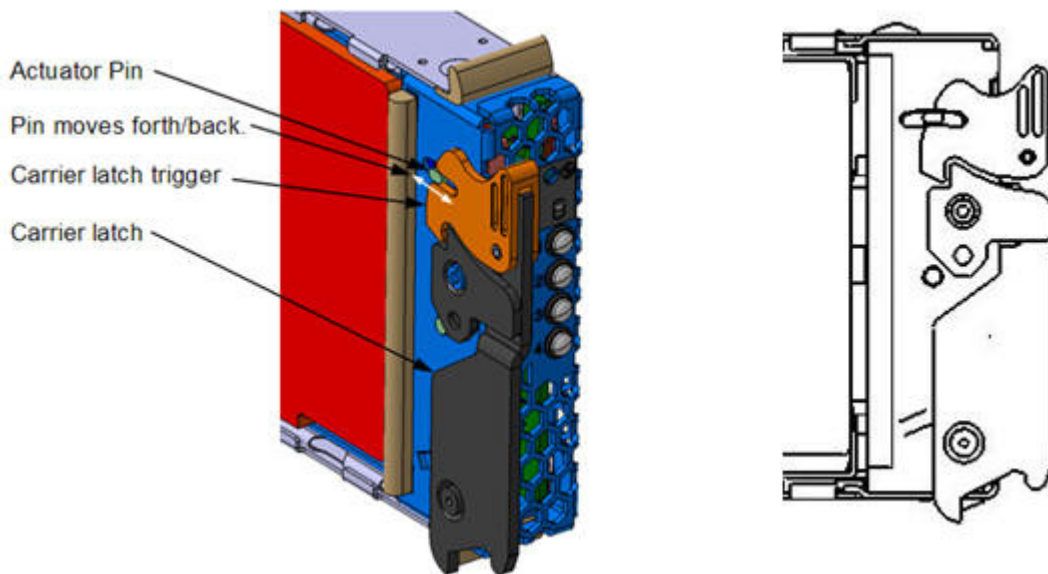
Figure 11 Electro-mechanical Actuator in Drive Carrier Latch (2 Views)

An electro-mechanical actuator locks the Drive Carrier's latch as soon as one or more drives are powered on in that Drive Carrier. This was implemented as a final check that the SSR has identified the correct Drive Carrier to remove in order to do the Drive service, as only the Drive Carrier being serviced will be unlocked. The actuator pin is moved to lock the latch trigger. See Figure 7 below. (The blue and red colors are only for contrast.)

NOTE – When the Drive Carrier is removed, if the actuator pin is accidentally moved to the locked position, it will be necessary to move gently back to the unlocked position with your finger before reinstalling the Drive Carrier.

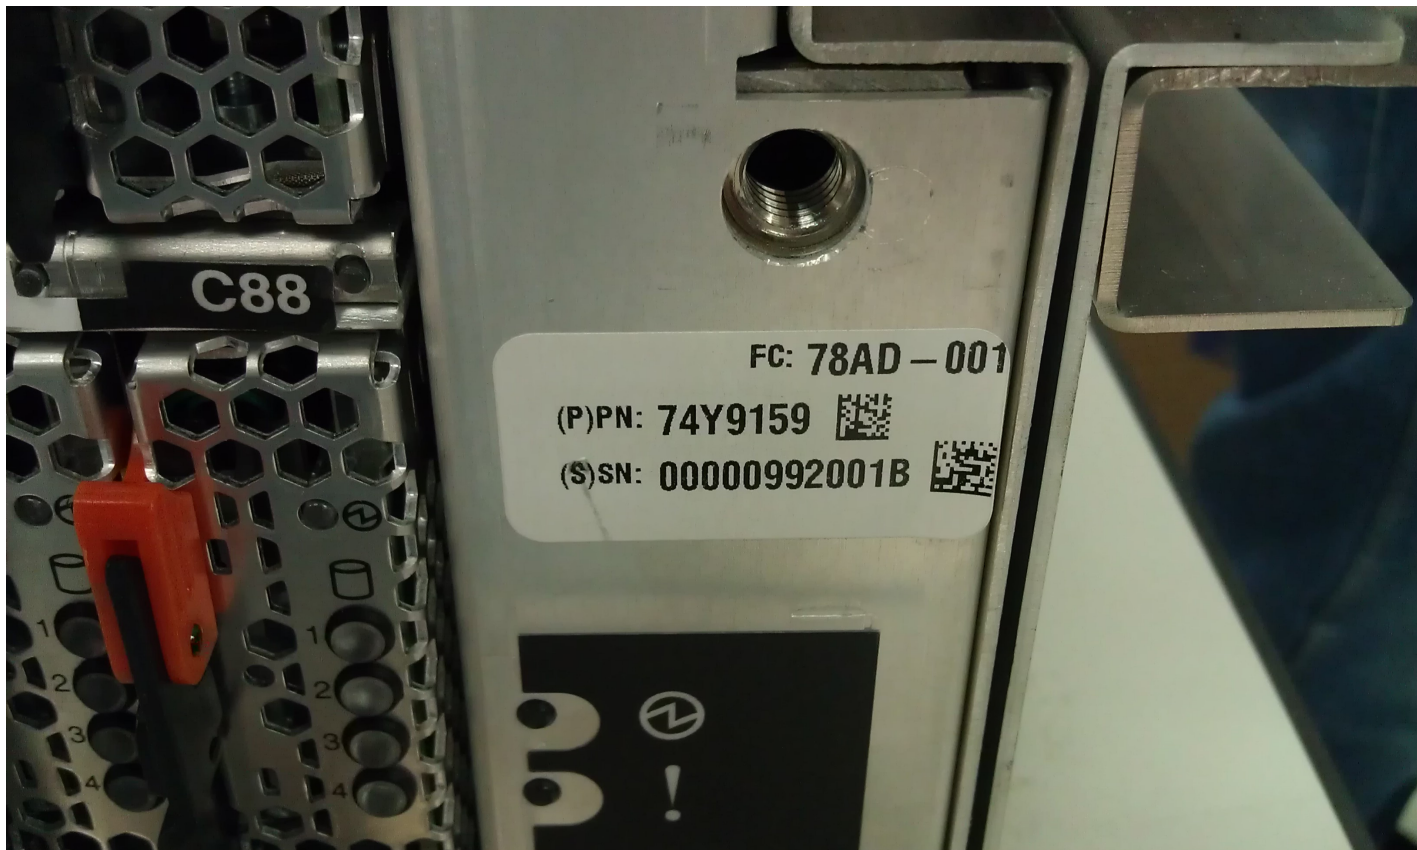
Figure 12 DE VPD Label

The VPD label is placed on the rear of a DE just above the drawer LEDs. The following picture shows the information contained in the label.

An example of a location code of Drive 4 in Drive Carrier 35 contained in the DE that this VPD label is attached to would be as follows:

Verify that the location code of the Drive to be replaced matches the enclosure VPD Label of the DE you have identified (see Figure 12).

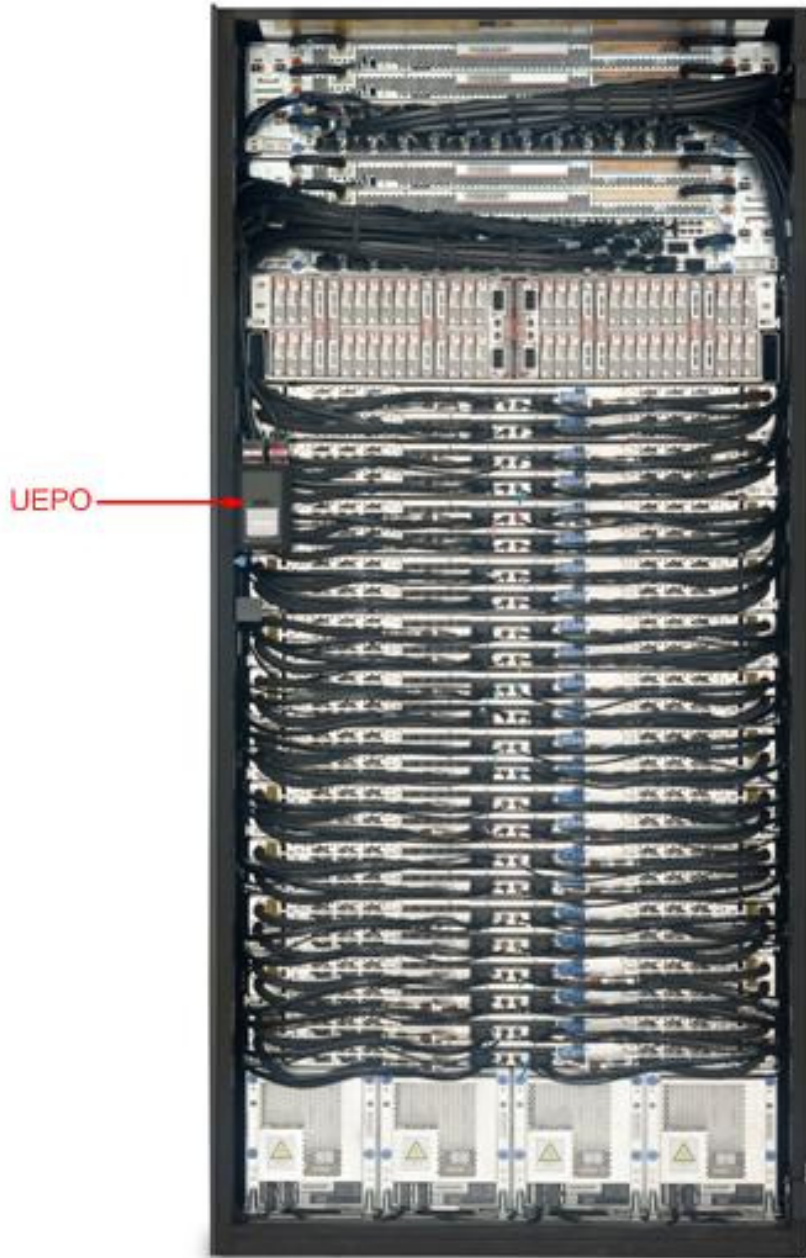
Figure 14 Frame Photo showing UEPO location

- STEP 3 Locate the frame. Confirm that it is the correct frame by checking that its UEPO Panel Identify LED is blinking. This LED is located on the UEPO panel and it is marked by the “!” symbol (see Figure 14 and Figure 15).

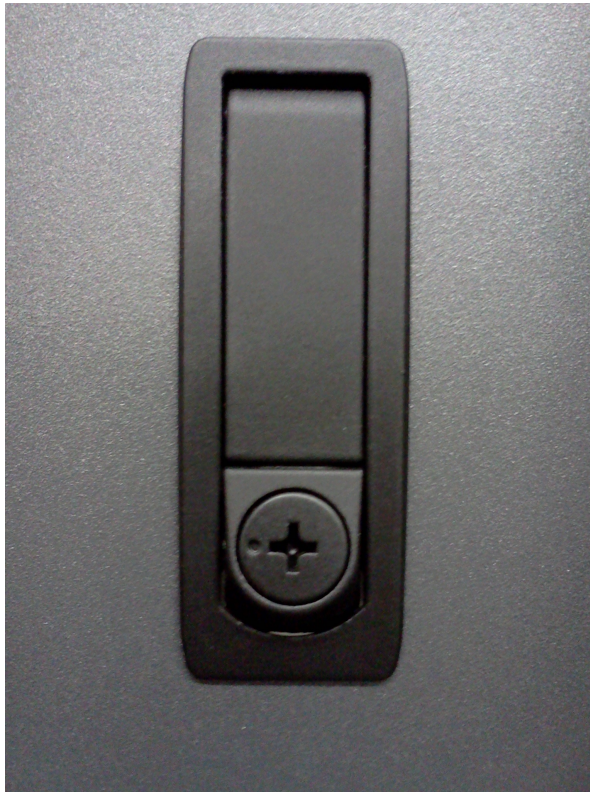
Figure 16 Door Latch

Locate the latch along the left side of the door; push in on the X button, the latch handle will pop out, extended out from the latch pocket. Grasp the latch handle and swing the door to the right (see Figure 16 and Figure 17).

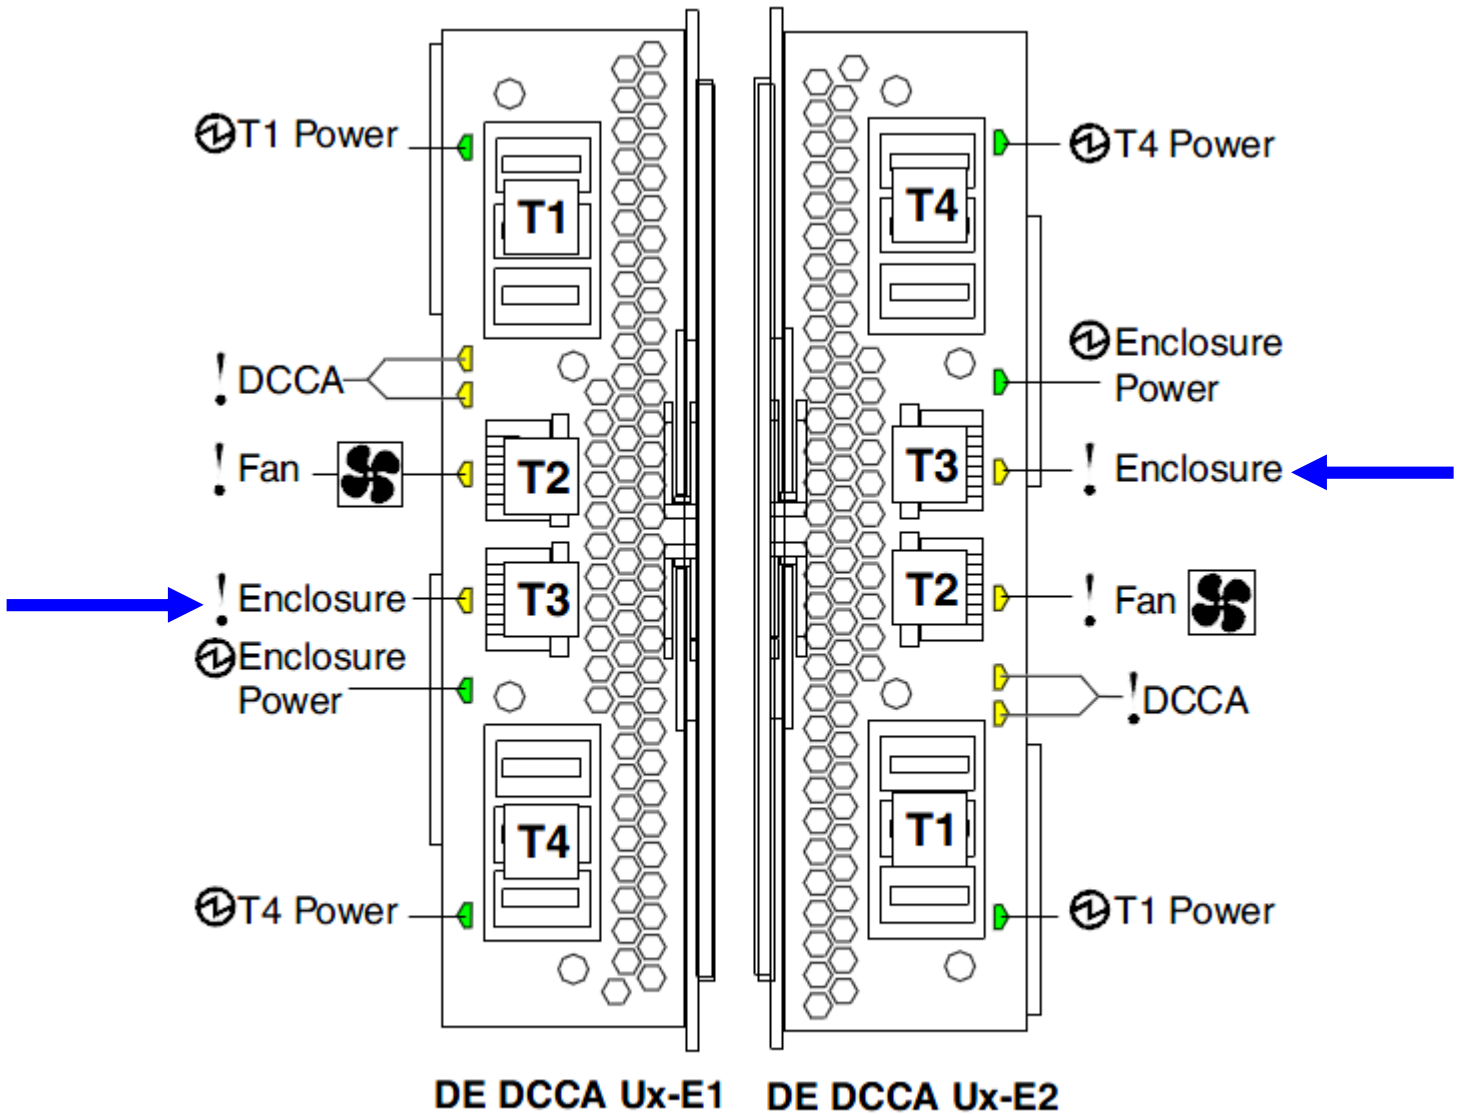
Figure 18 The Front DE Enclosure ID LED is located on the DCCAs

Identify the Disk Enclosure requiring service by looking for the blinking amber Enclosure ID LEDs on the DE DCCAs on the front side of the Disk Enclosure (see Figure 18) OR on the right side of the rear of the Disk Enclosure (see Figure 19).

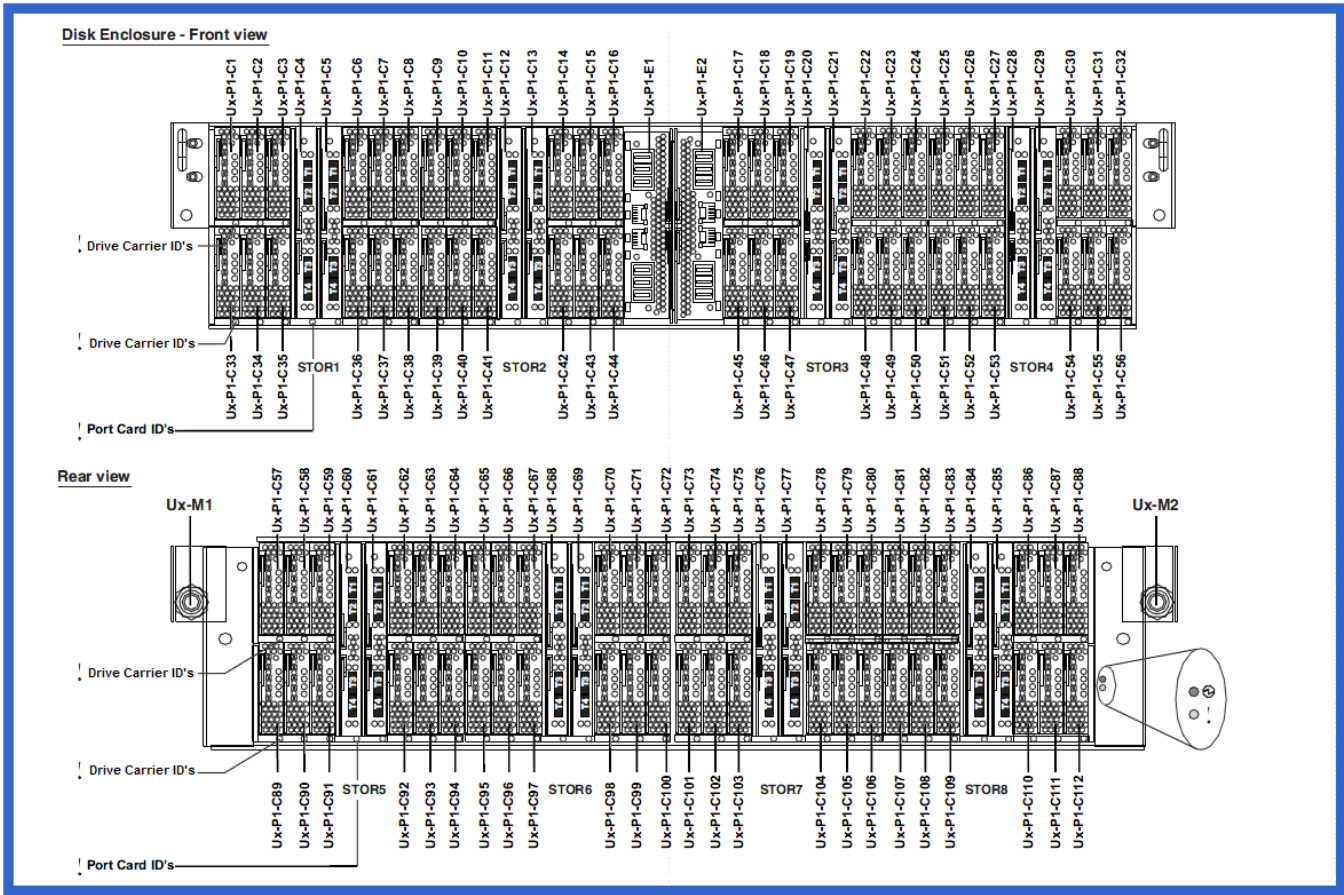
Figure 20 Disk Enclosure LEDs

NOTE: The Drive Carrier Slot ID and the Port Card Slot ID LED functions have 2 LEDs on the backplane going into a single light pipe. If the LED is not blinking, do not assume that the LED is broken as it is very unlikely that both are broken (see Figure 21) If this LED is not blinking, it is recommended to stop and contact next level of support.

NOTE: After the drive is replaced or resumed, the following LEDs should turn off: the Drive Carrier Slot ID LED, the Port Card Slot ID LED, the DE Enclosure ID LED, and the UEPO Panel ID LED.

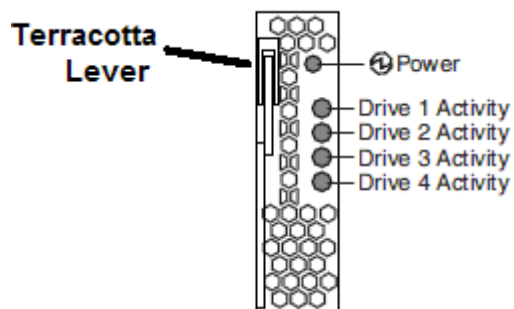
Figure 23 Drive Carrier LEDs Drawing

- c. Verify the green Drive Carrier power LED is off. Do not remove the Drive Carrier if its power LED is on. If the power LED is illuminated at least one hard drive or SSD is active. Removal of the carrier while any drive is active may BRING DOWN THE FILESYSTEM. Make sure all green drive activity LEDs on the Drive Carrier are off before removal of the Drive Carrier (see **Error! Reference source not found.**Figure 23).
- d. Check that the Drive Carrier latch is unlocked. Remember that the latch for the Drive Carrier is on the left side. Make sure you have the correct latch and you are not off by one slot. When the latch is unlocked, a slight downward and outward pressure with your finger tip on the terracotta touch point will move the latch. No side to side motion is required.

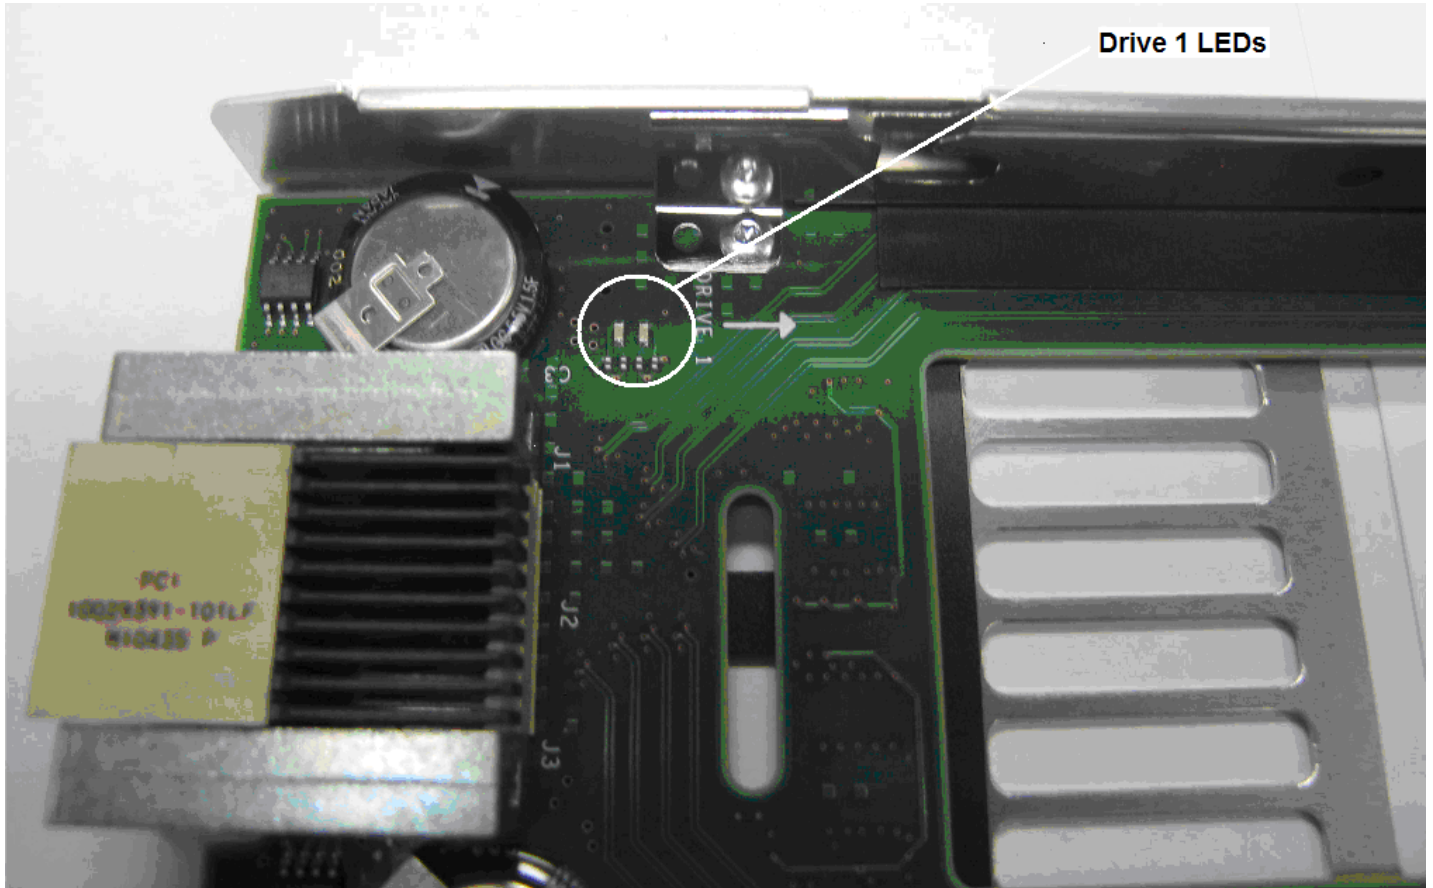
Figure 24 Drive 1 LEDs and arrow

STEP 18 Confirm the Drive (or possibly multiple Drives) to be replaced by observing the Drive Identify LED. Locate the blinking amber Drive Identify LED which indicates the position of the Drive to be replaced. There are 2 LEDs for each drive position for redundancy. The amber LEDs are next to a silk screen arrow pointing to the latch of the

Drive to be replaced, and are labeled “Drive 1”, “Drive 2”, “Drive 3”, and “Drive 4”. (see Figure 24 and Figure 25).

NOTE: The DE Port Cards control 12 Drive Carrier cards in a redundant fashion. Each DE Port Card controls one of two DRIVE Identify LEDs for each drive position. Since there are two separate LED drivers and a low duty cycle, the LEDs will blink out of phase. If there is a broken LED, there will be only a single LED blinking for the drive position – this is not a problem and the Drive Carrier should not be replaced for this since the redundancy is working as intended.

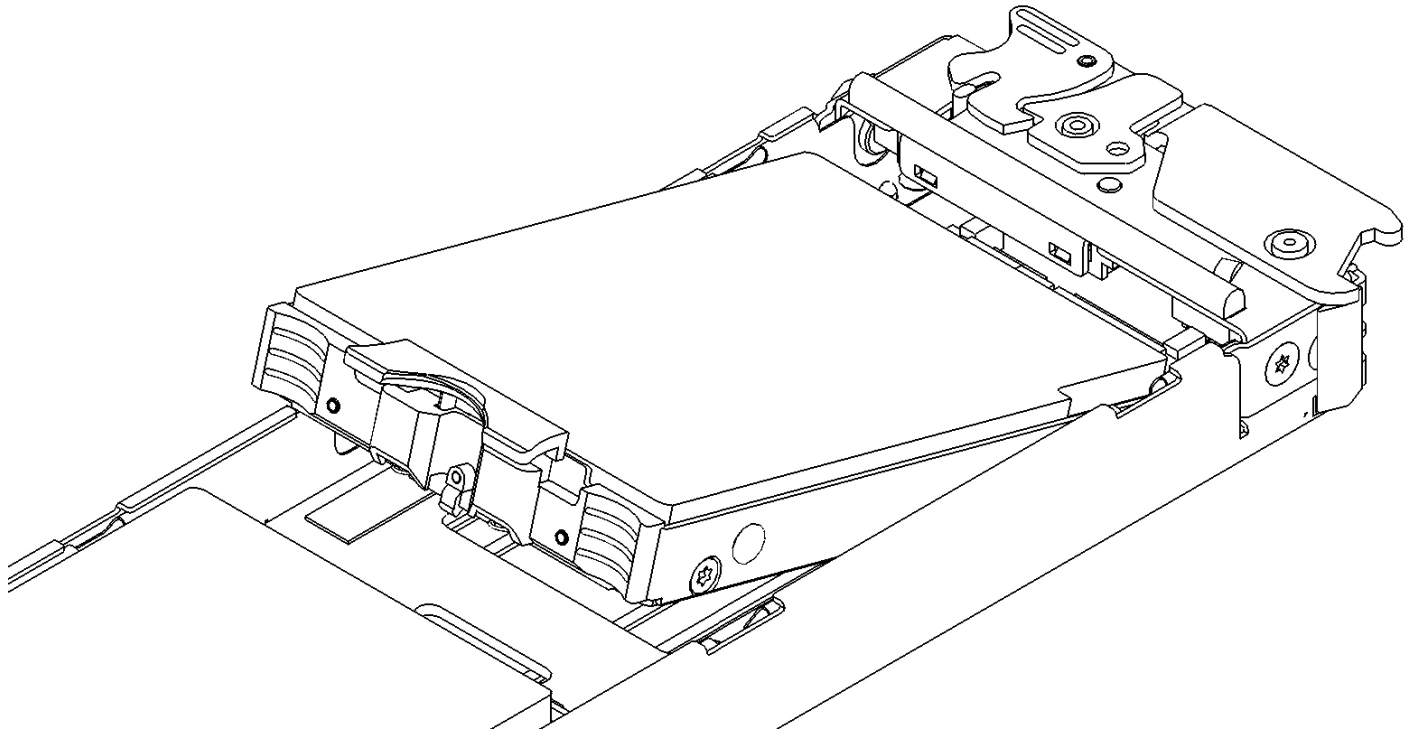
Figure 26 Drive Removal

To remove the drive from the Drive Carrier:

- a. Lift the blue latch in order to slide the tab out of the slot in the Drive Carrier PCB.
- b. Slide the hard drive or SSD away from its connector (towards the latch end).
- c. Lift the latch end first out of the Drive Carrier, followed by the connector end.
