The BP Deepwater Oil Spill - Why Top Kill May Have Failed and Monday Open Thread 2

Posted by [Heading Out](#) on May 31, 2010 - 4:15pm

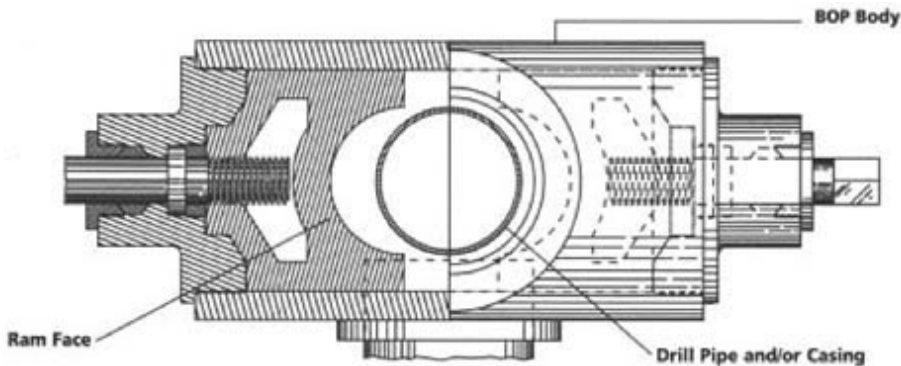
MO BOP in the fully open position. The ram faces are retracted back, away from the pipe in the bore.

BOP open allowing flow through the annulus ([ASME](#))

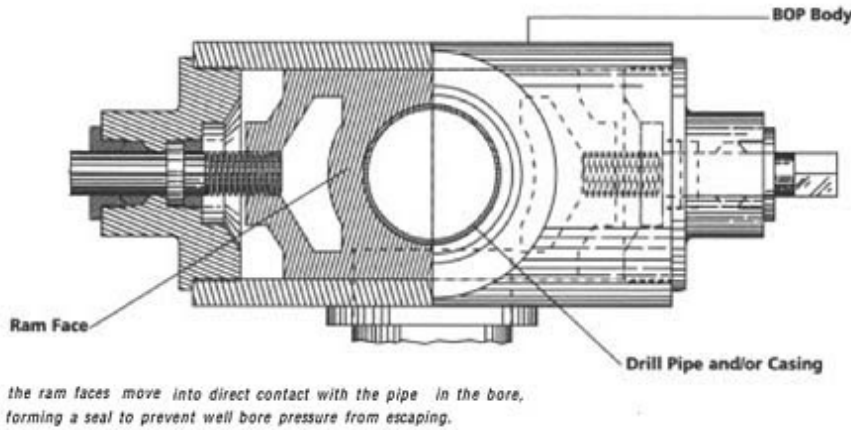
BOP closed against the pipe, sealing the annulus ([ASME](#))

A BOP could have two of these mounted so that one sealed to the production casing in the well, and one to the drill pipe, but if underwater then the production casing is tied back to the Wellhead Collet Connector, and then the only tube running through the BOP will be the DP, to which they will seal.

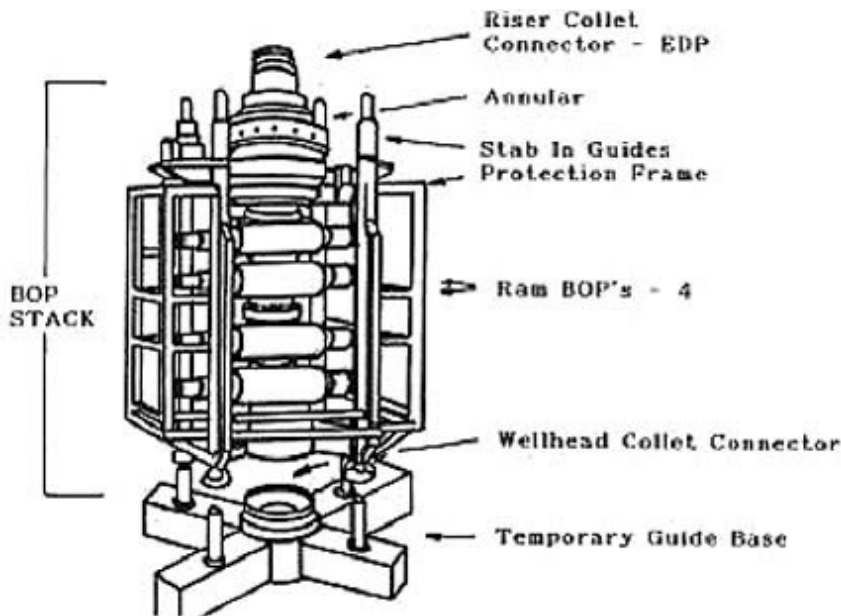
BOP connection to casing at the seabed ([PCCI report for MMS](#))

The problem that this leaves, in the current situation, is that the pipe that runs through these two seals is open at the bottom to the oil flow. So how can the flow through this be stopped?
