XLI. *An Account of the Effects of Lightning in St. Bride's Church, Fleet-street, on the 18th of June 1764: In a Letter to Mr. Benjamin Wilson, F. R. S. from Edward Delaval Esq; F. R. S.*

Read June 28, 1764. **T**HE inclosed is an account of the effects of the lightning on the steeple and spire of St. Bride's church, with drawings [TAB. XIV. XV.] which very accurately express the parts damaged by it.

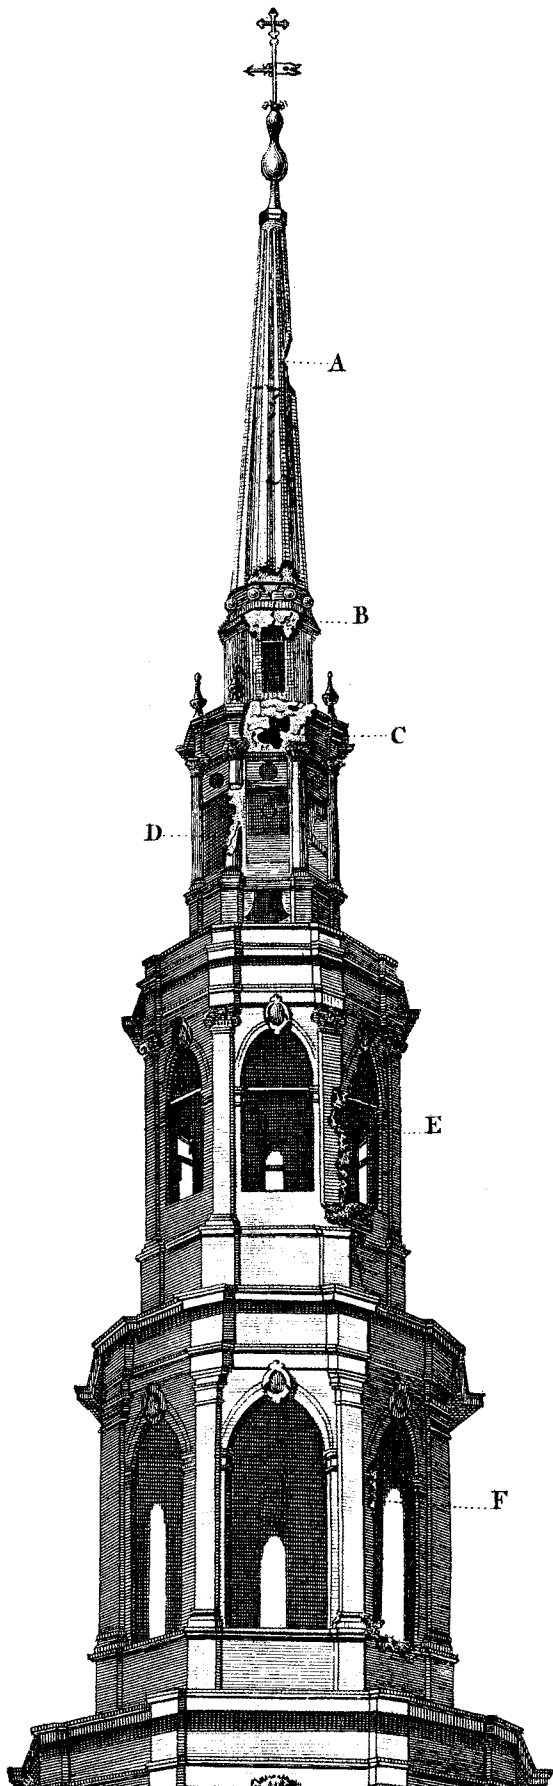
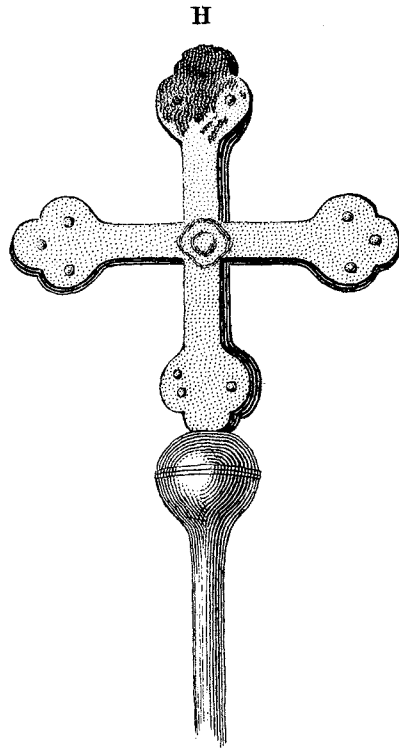
At this place the first marks of it are seen: at H the top of the copper cross, which is the highest part of the building, the gilding is by the explosion partly torn off and partly discoloured, so as to differ remarkably from the rest of the cross where the gilding is very well preserved. Some small pieces of solder are melted; and all this part appears as if it had been exposed to the fire.

The next stroke is about four feet below: at this place four iron bars lie horizontally across the spire, and are tied together by chain bars which are inclosed in the stonework: where the end of one of the cross bars is inserted in the stone, the lightning has burst open the hole described at C, and, when the same is viewed at the outside, a great part of the cornice appears to be broken off.

At D, where the two iron bars serving to support the top of the windows meet and are joined together, the lightning accumulated in them has broken off the pier by which they were inclosed.

At G, the next arch under this, the force of the lightning seems to have been much diminished, a small part of one stone only being broken.

From the wall at the West side of the South window of the belfry some stones are thrown down: one chalky stone in particular is reduced into an impalpable powder, and the wall under the West window is almost covered with the powder: this stroke seems to have been directed towards the bells one of which is very near the place damaged: the bells have not been examined; nor can they, as I am informed, without danger of shaking the spire by their motion.

From several observations which I made on this occasion, such a communication seems necessary in buildings of this form. The iron bars, which were fixed in the stonework of the East arches were struck by the lightning, while those in the arches fronting them on the West side of the same story remained untouched by it. So that I do not apprehend, that a conductor communicating with the West arches only, would have preserved the opposite ones from the damage which they have suffered.

I think, a conductor of metal less than six or eight inches in breadth, and a quarter of an inch in thickness (or an equal quantity of metal in any other form that may be found more convenient) cannot with safety be depended on, where buildings are exposed to the reception of so great a quantity of lightning. These are the only points in which I have ventured to differ from Dr. Franklyn.

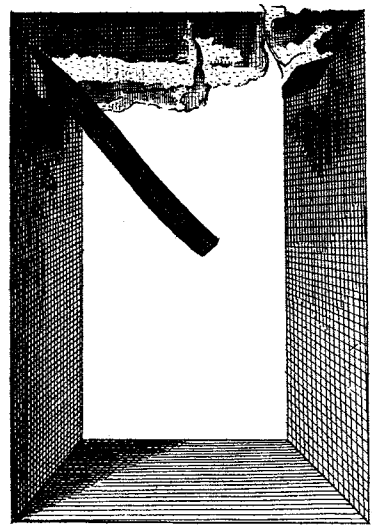
Fig. 2.

At Fig 2, a bar of iron, which served to support the top of the window in the same manner as those last mentioned, 21 inches long clear of the stonework, and half an inch thick, is broke and bent into the position expressed in the drawing; and the stones immediately above it are shattered and disjointed.
