HP 9153/54 A/B Service Manual

Manual part number: 5958-4122
Microfiche part no. 5958-4125

Printed: MAY 1988
Printed in U.S.A.

Edition 2
E0488

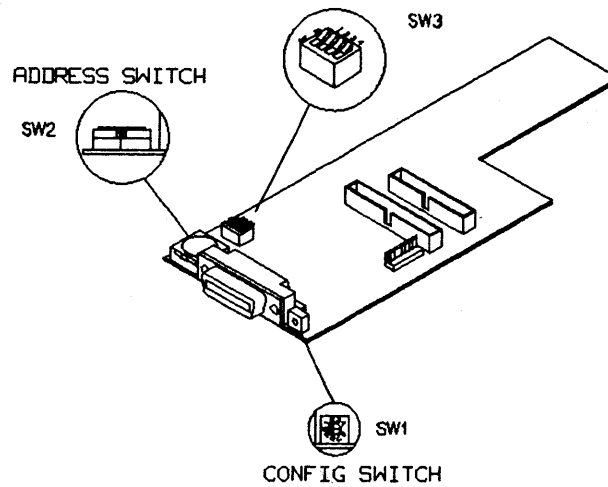
Switch bank SW3, located on the Controller PCA near the HP-IB connector, is used to configure the unit and initiate the selftest routines. The following figures show the location of SW3 and the different configurations available.

SWITCH LABEL				HP 9153A and HP 9154A CONFIGURATION
FLOPPY	10	X	* TEST	
OFF	ON	OFF	OFF	10M BYTE HARD DISC WITH FLEXIBLE DISC
ON	ON	OFF	OFF	10M BYTE HARD DISC W/O FLEXIBLE DISC
ON	ON	ON	OFF	DONT CARE (UNUSED)

SWITCH LABEL				HP 9153B/HP 9154B CONFIGURATION
FLOPPY	10	X	* TEST	
OFF	OFF	OFF	OFF	20M BYTE HARD DISC PLUS FLEXIBLE DISC
ON	OFF	OFF	OFF	20M BYTE HARD DISC W/O FLEXIBLE DISC
OFF	ON	OFF	OFF	VIRTUAL 10M BYTE HARD DISC WITH FLEXIBLE DISC
ON	ON	OFF	OFF	VIRTUAL 10M BYTE HARD DISC W/O FLEXIBLE DISC
ON	ON	ON	OFF	DONT CARE (UNUSED)

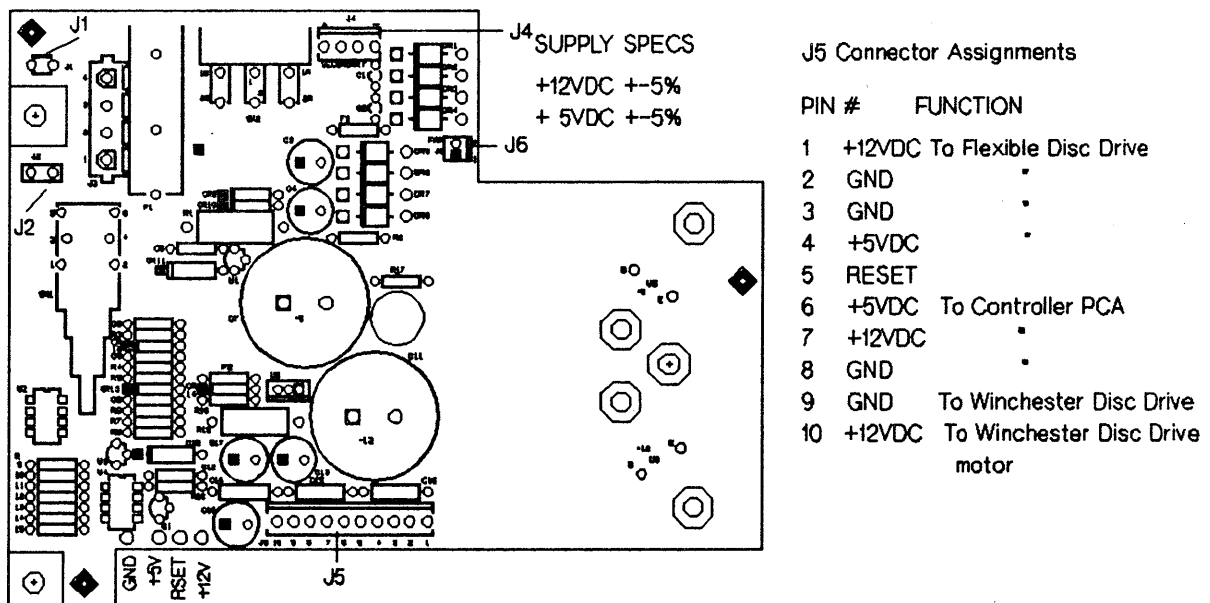
Figure 8-1. Power Supply PCA (09153-67501).

Power supply voltages should be checked before any troubleshooting procedures are started. The following figure shows the location of power supply voltage test points. This will aid you in isolating the failure to a replaceable assembly. The power supply is not an exchange assembly.

1. Check power supply voltages (Figure 8-1)
2. Ensure that all cables are connected properly.
3. Ensure that configuration switch on the controller board is set correctly. (Figure 8-8)
4. Replace controller if none of the above correct the problem.

1. Check power supply voltages (Figure 8-1)
2. Ensure that all cables are connected properly.
3. Ensure that configuration switch on the controller board is set correctly. (Figure 8-6)
4. Ensure that configuration switch on drive (See Figure 8-6) is set correctly.
5. Replace controller if none of the above correct the problem.
6. Replace the original controller in the product and replace drive if controller replacement does not correct problem.

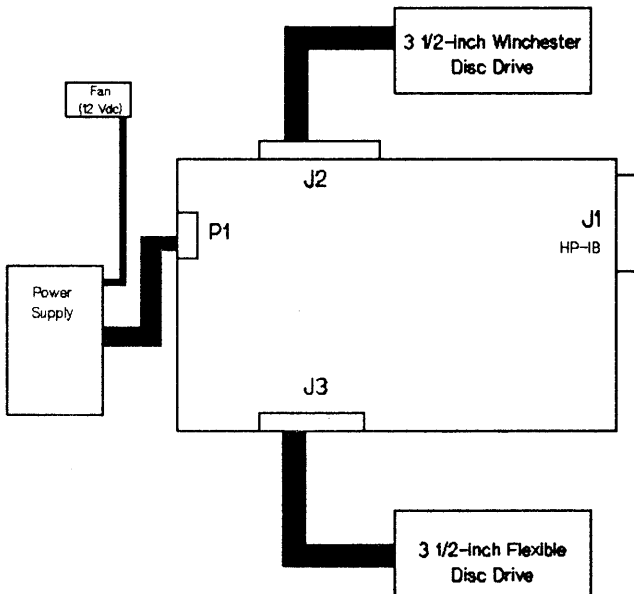
Figure 8-7. Cable Interconnect.

Figure 8-7 shows the cable interconnect for the HP 9153/54A.
