IBM WebSphere DataPower 7993 SOA Appliance - Migrating to the newer or later firmware

§ This presentation describes the firmware upgrade process for a WebSphere DataPower 7993 SOA appliance to the newer firmware. The presentation also references migration tips to consider during migration and testing.

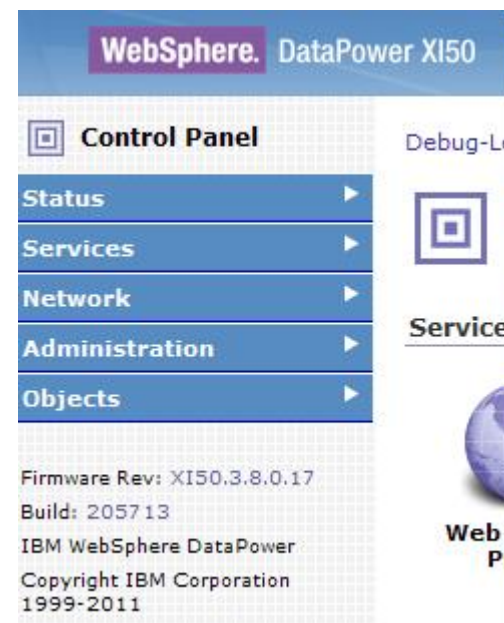
Identify The Firmware Image File Which Matches Your Appliance

- § For the DataPower firmware image names have the following format: `zzNNNN.licenses.scrypt2`.
- § **DataPower model:** `zz` represents as DataPower model which is on the top left of the banner on WebGUI page as `XI50.....`. For example: `xiNNNN.licenses.scrypt2`.
- § **License Information:** It represents what licenses you have in this appliance. For a DataPower with ODBC license, the image would be: `xiNNNN.odbc.scrypt2`.
- § **Current Firmware:** `NNNN` represents current firmware. For a DataPower with ODBC license and you want to upgrade to 3.8.1.18 the image would be: `xi38118.odbc.scrypt2`

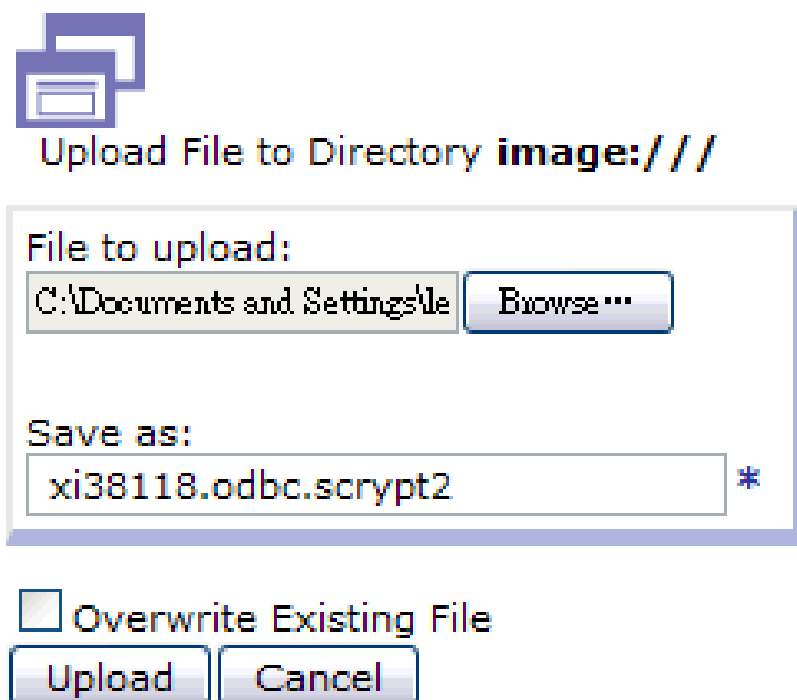
7. Browse to the prerequisite firmware and upload

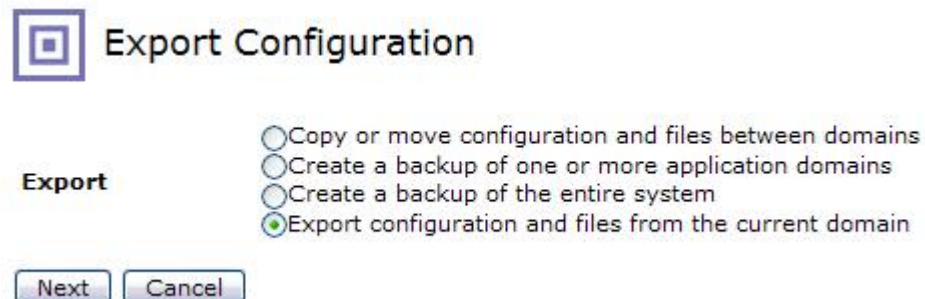
- § Select **Create a backup of the entire system**, and click **Next** to display the file name screen.
- § You should provide a meaningful description of the appliance configuration you are exporting in the comment field. This will help to identify the backup at a later date.

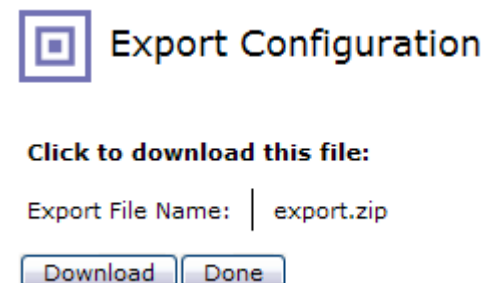
- § Specify a file name for the export file that will be created in the export: directory. The default file type is .zip. If a file with the specified name already exists, it will be overwritten.
- § Click **Next**. The exportable appliance configuration will be written to the specified file (in the export: directory). Copy this file to a safe (off-box) location. When you import the configuration into the new appliance, this file should reside on your client system, so you may wish to perform the copy using the Download button, which will copy it to your browser client machine.
- § Click **Done**.
