Power Systems

*Failing function codes, failing items,  
and symbolic FRUs*

This edition applies to IBM Power Systems™ servers that contain the POWER9™ processor and to all associated models.

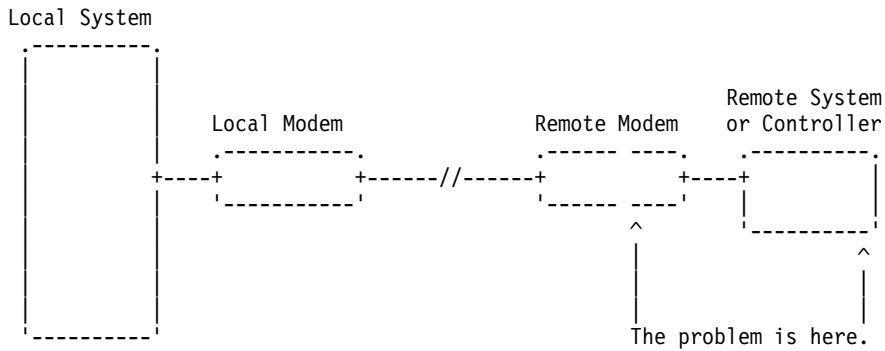
### UJ0E6

The problem has been isolated to the remote modem, or the remote system or controller.
